# **Hazard Survey for Port Houston – Expansion Channel Improvement Project – Amendment 6 Spilmans Island/Morgan’s Point Geophysical Survey**

Methodology Report | Harris County, Texas

1910781042 02 | September 15, 2020

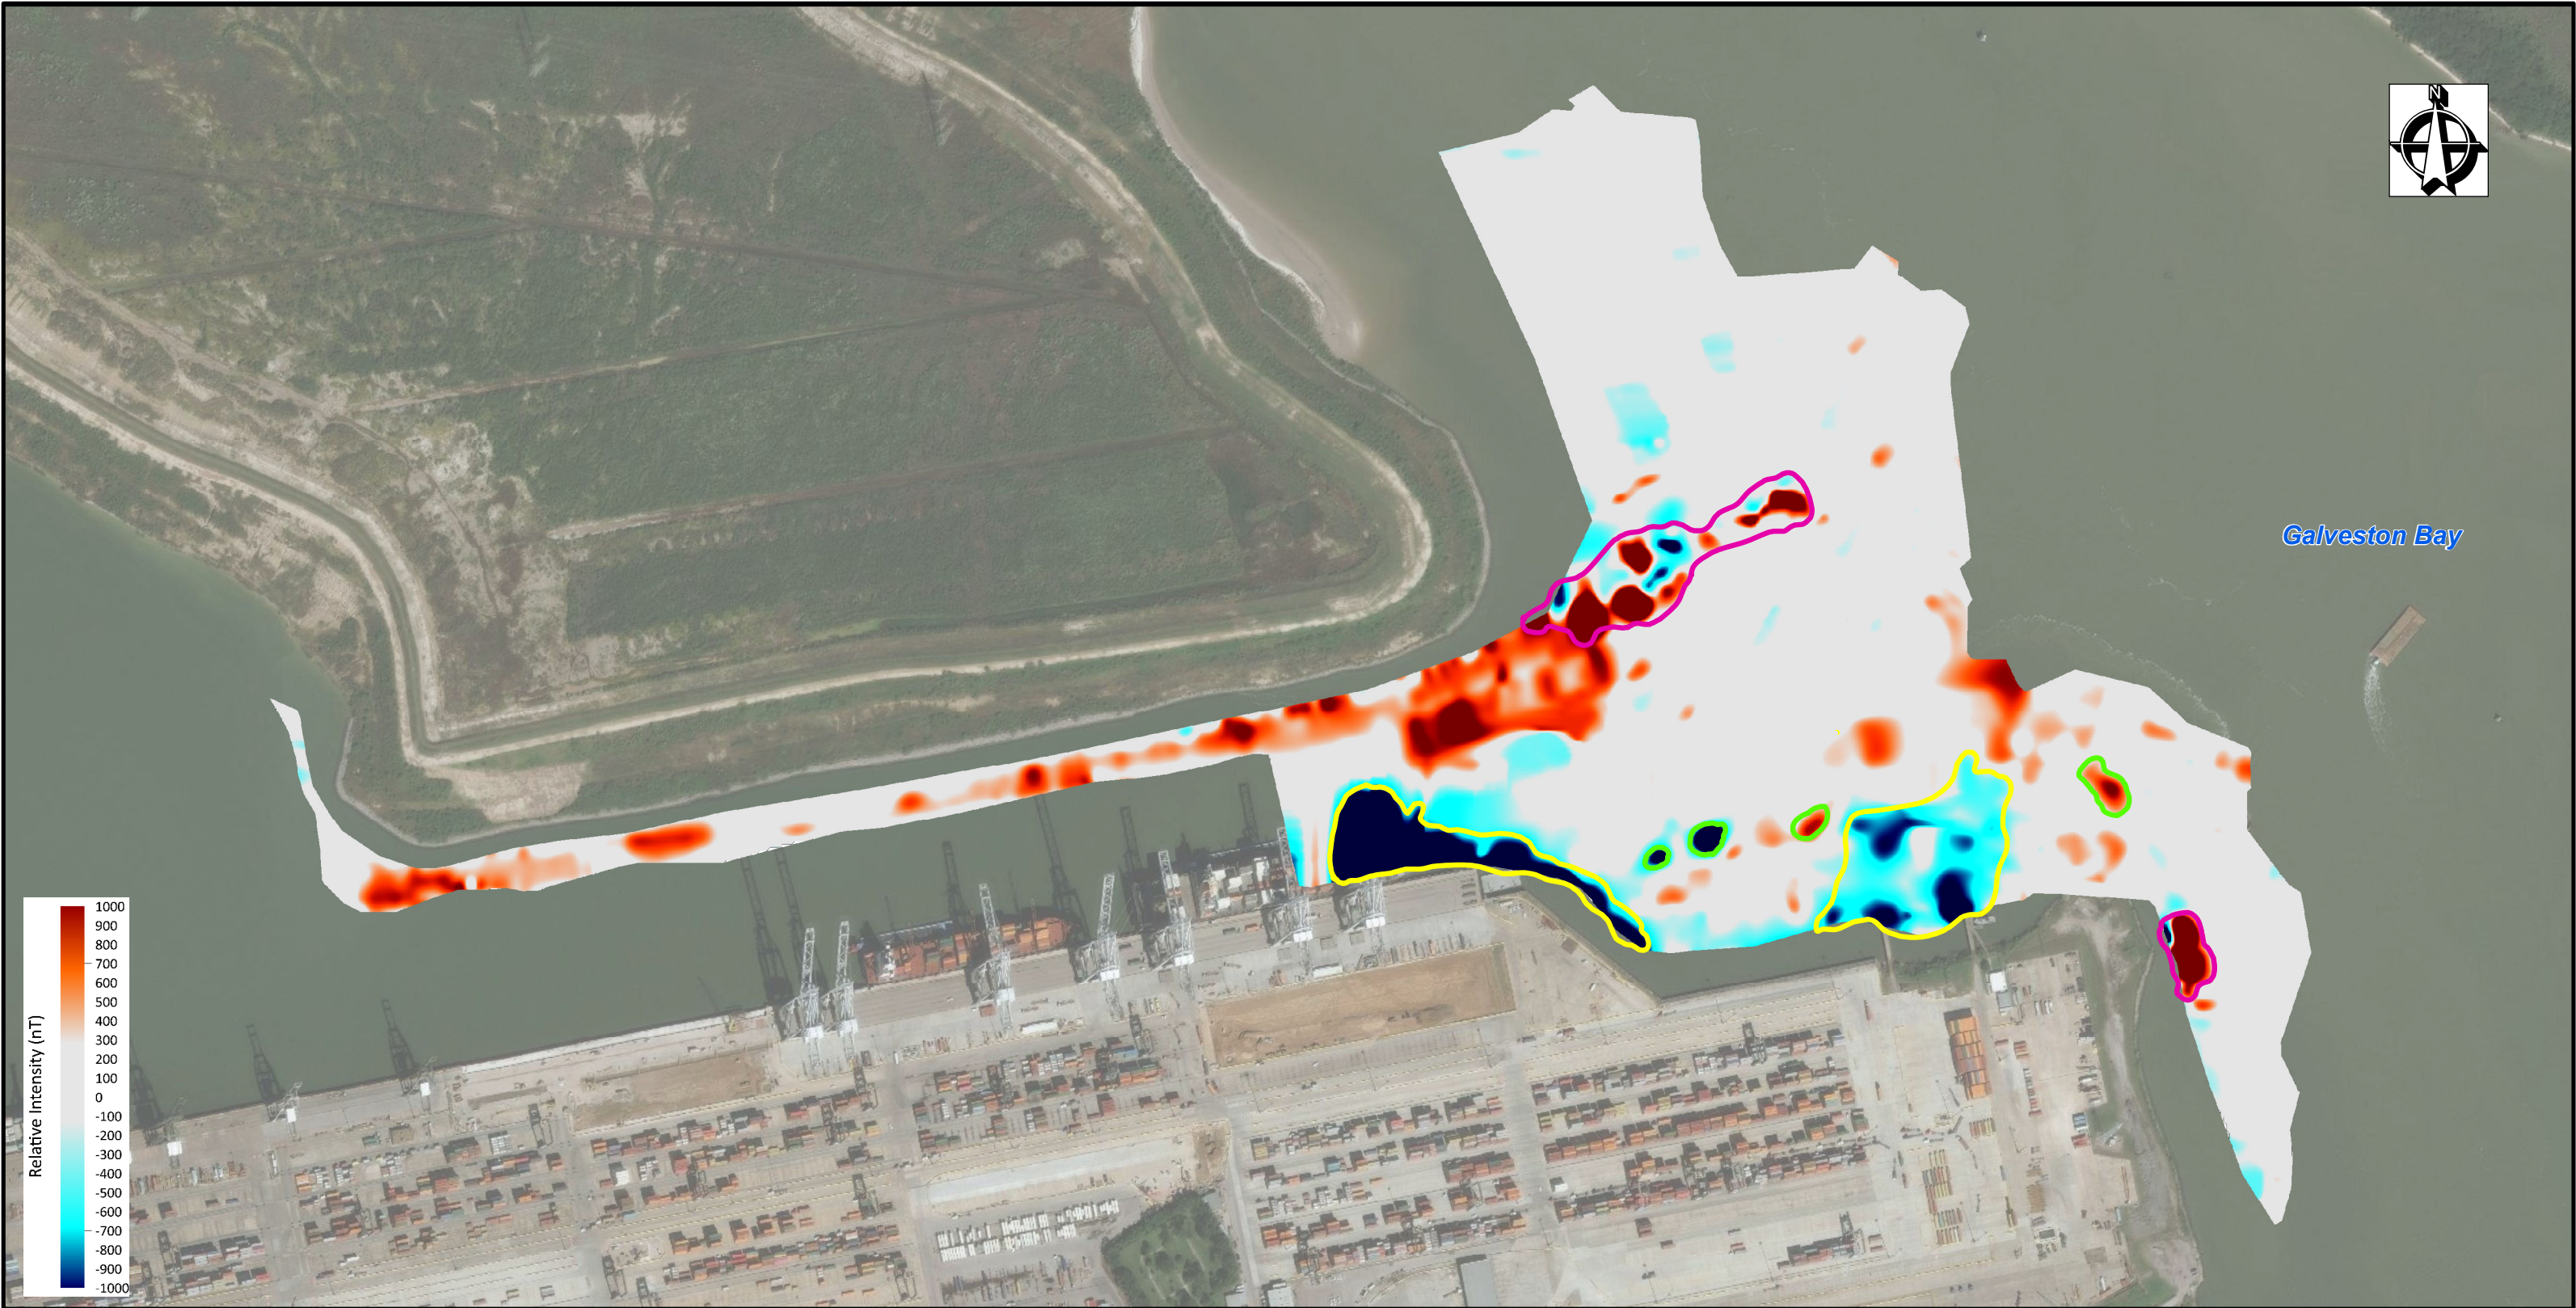
HAZARD SURVEY - SPILMAN  
MAGNETOMETER INTENSITY FIELD MAP  
GALVESTON BAY AREA  
HARRIS COUNTY, TEXAS

While interpreting the magnetometer data, there is a distinct anomaly on the southeastern portion of Spilmans Island. These anomalies do not correlate to any hazards seen in the sidescan sonar data; however, when plotted in plan-view with mapped locations of pre-existing structures, the anomalies appear to geospatially align with old infrastructure that is visible in historical aerial imagery. However, these magnetometer anomalies are the only evidence that aligns with old infrastructure. In many areas where structures are documented in historical imagery, new and unique structures are shown to have replaced them throughout the time elapsing between their initial construction and the present. The remaining magnetometer anomalies seem to align with existing infrastructures such as docks, bulkheads, piling clusters, etc.

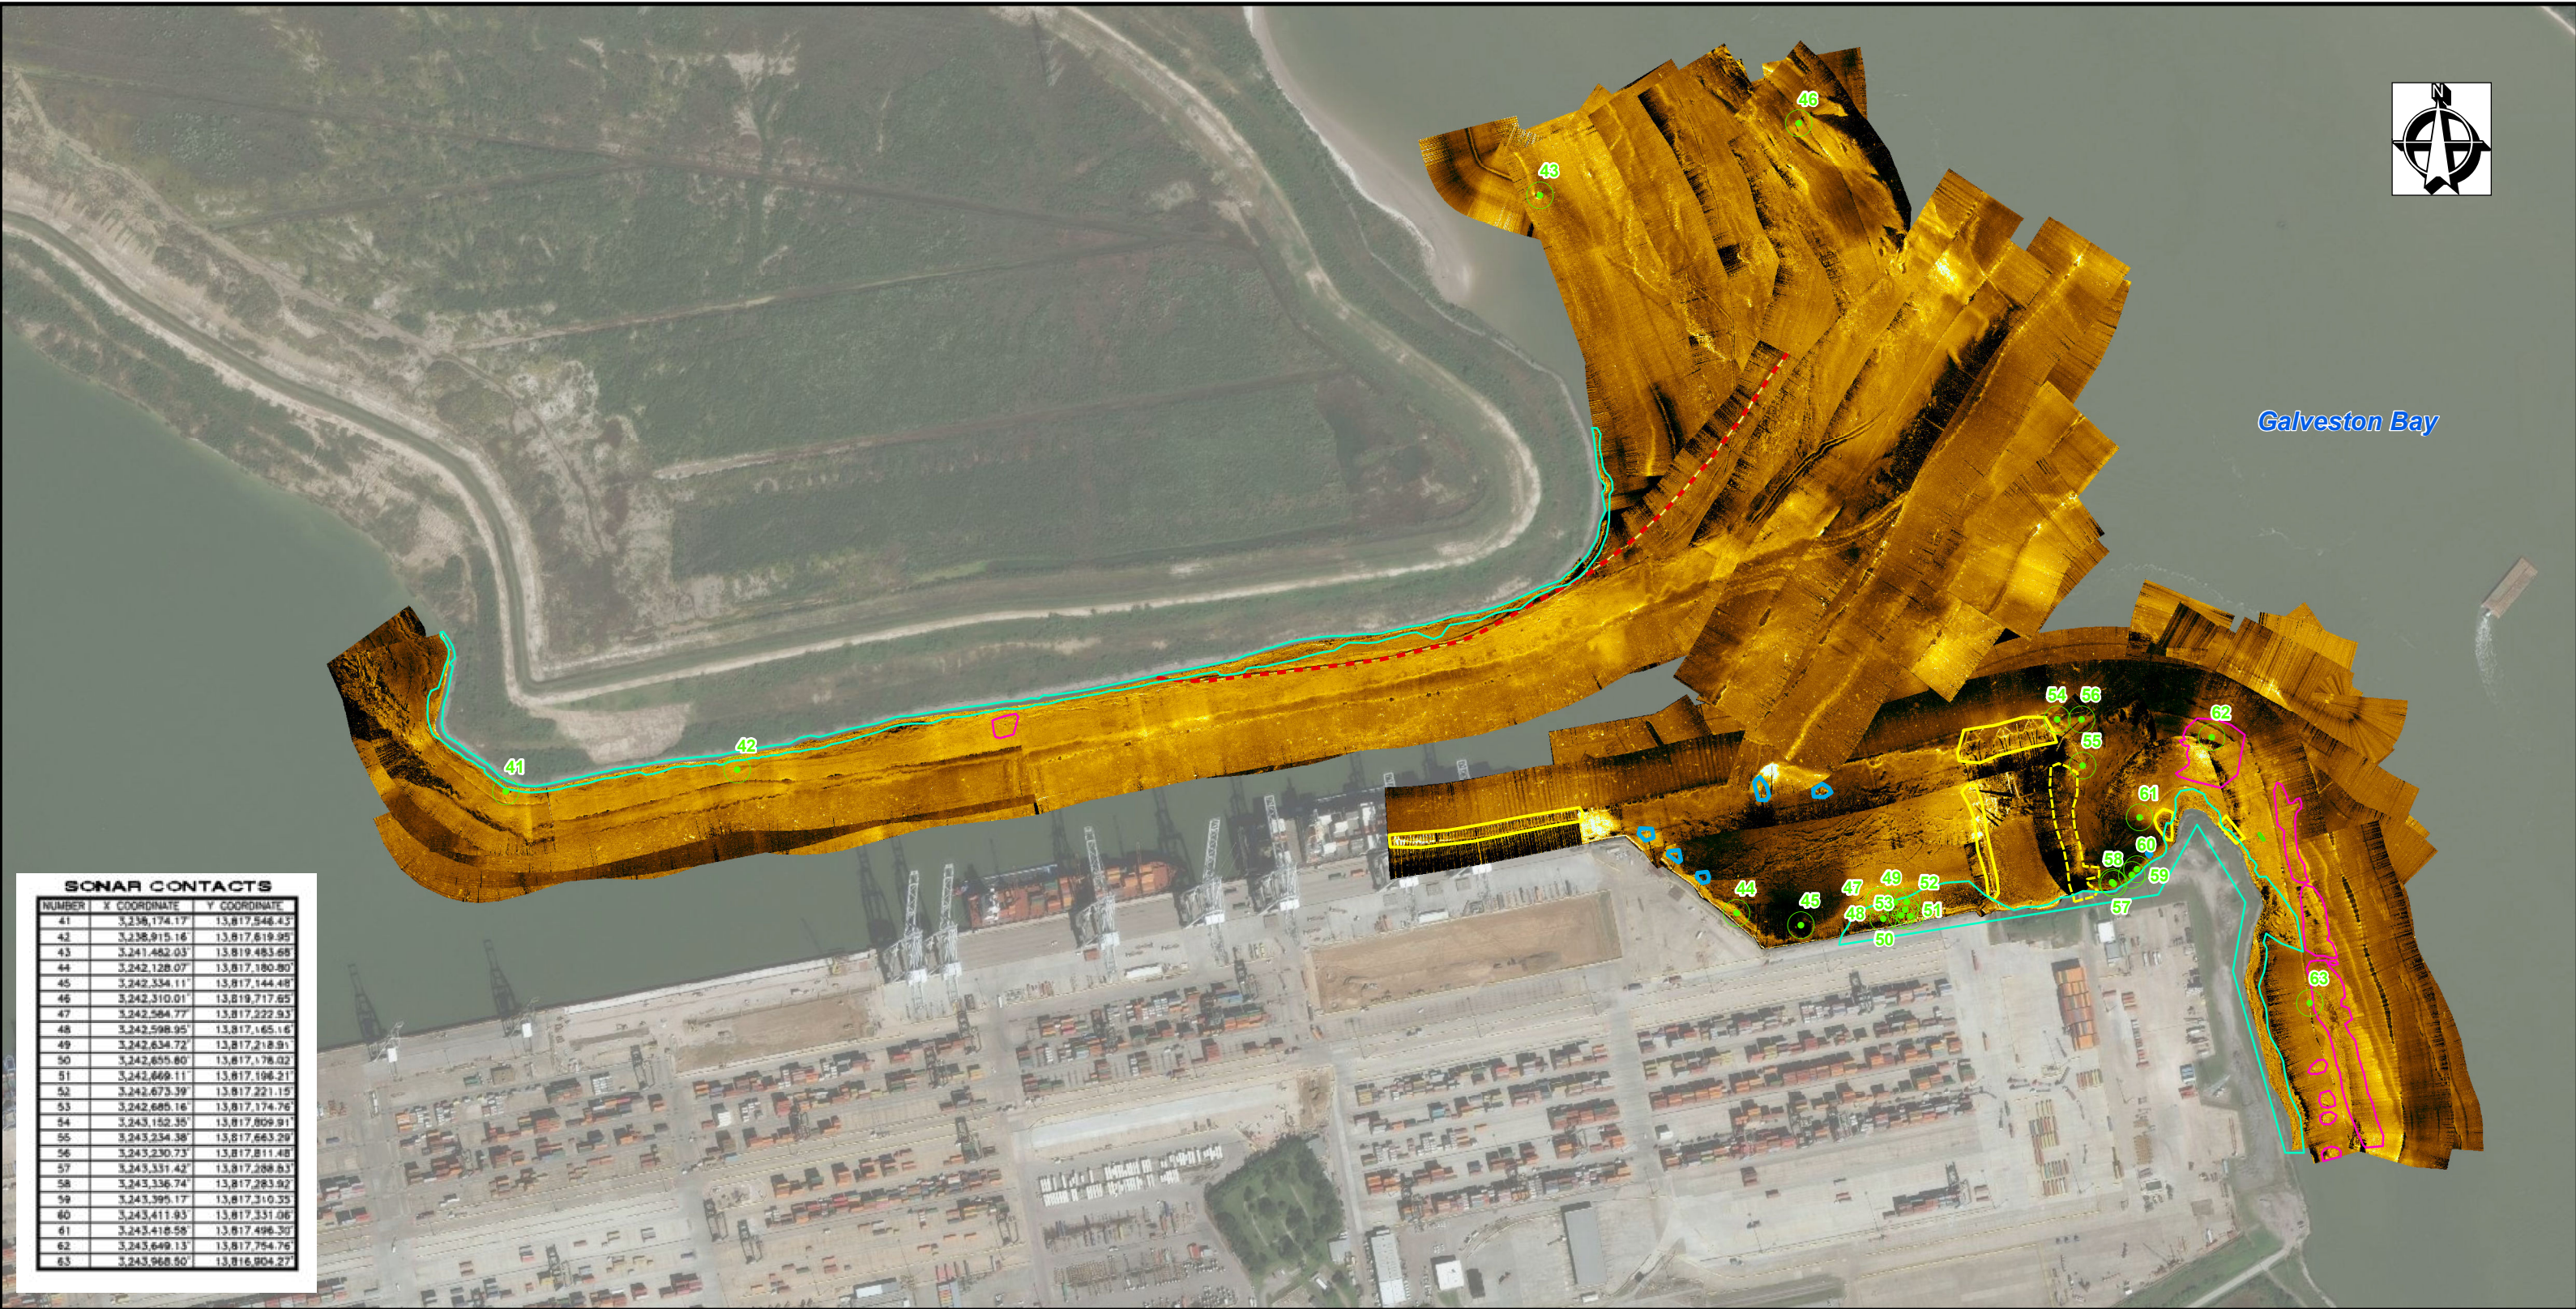
HAZARD SURVEY - SPILMAN  
SIDE SCAN SONAR MAP  
GALVESTON BAY AREA  
HARRIS COUNTY, TEXAS

Observations made while scrutinizing the sidescan acoustic imagery shows bright reflectors along the banks of Spilmans Island and Morgan's Point. These intense reflectors along with the texture is interpreted to be armored rip-rap. This aligns with observation from the survey vessel as well as aerial imagery of the location. Located at the tip of Morgan's Point and to the south there is also a sizeable debris field. The debris field is isolated from the rip-rap that lines the shoreline. The debris fields are interpreted to largely consist of unidentified industrial and shipping debris from passing vessels, as well as debris that over time has traveled from land into the channel such as pieces of rip-rap. These debris clusters also tend to exist near piling and dock structures. There is also what is interpreted to be an abandoned piece of dredge pipe on the northern bank that extends onto Spilmans Island. Outside of these clusters of debris the survey area is in an area with a lot of past and present infrastructure. There are multiple dock structures currently present in the area of Morgan's Point. Along with the dock structures, piling clusters may present challenges in dredging operations. The dredge pipe, debris clusters, and existing infrastructure is visible in the sidescan sonar mosaic in Appendix A in this report as annotated features. Other existing hazards can be found in the sidescan sonar contact report located in Appendix B. Fugro calls attention to these dense debris fields and contacts, as they may impact future dredging operations executed in the area covered by the survey.

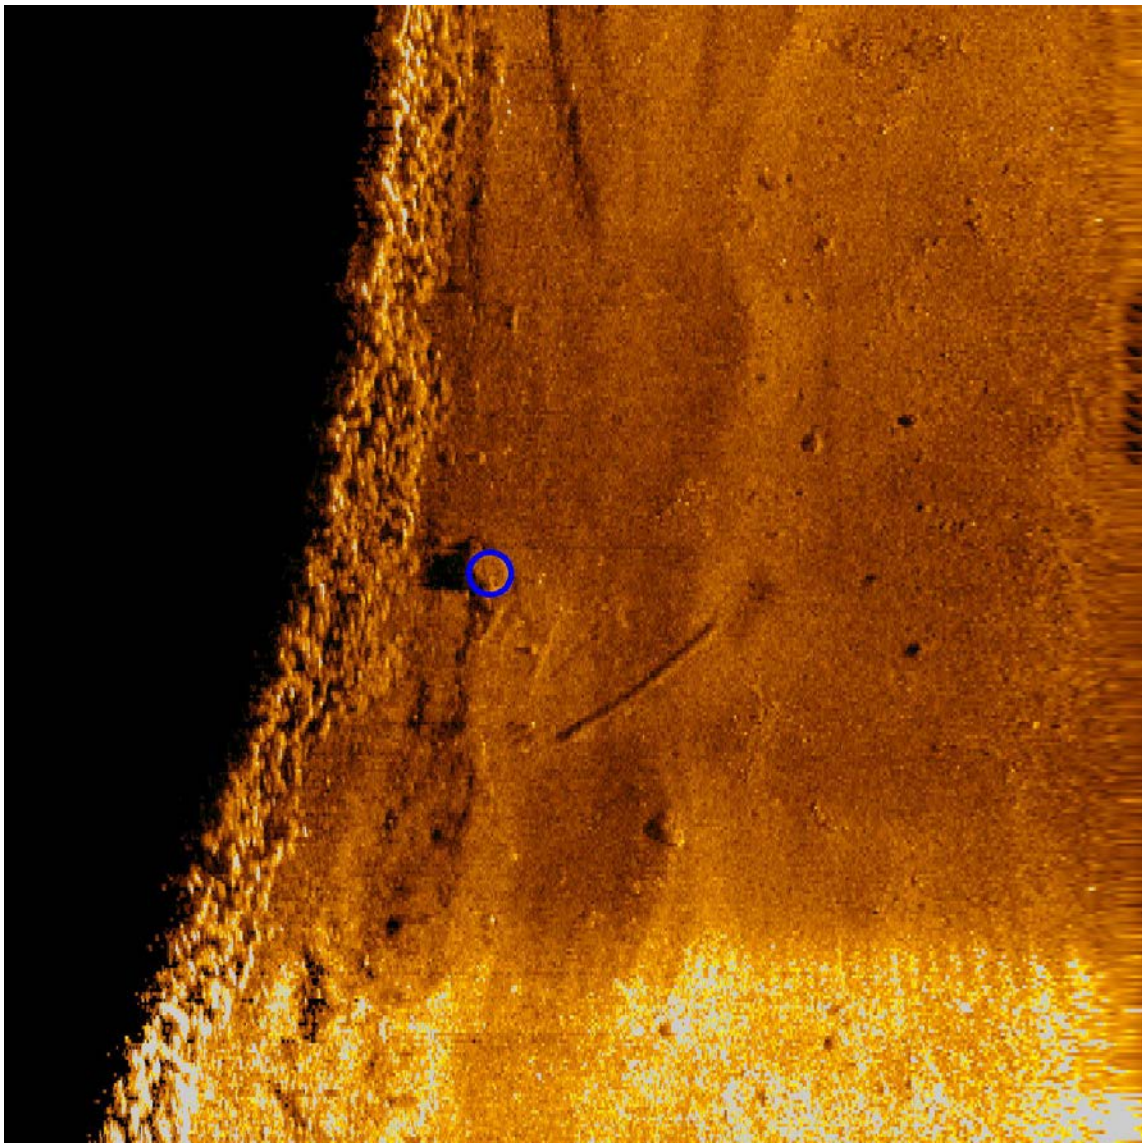
#### Contact 41

- Target Width: 4.87 US ft
- Target Length: 8.70 US ft
- Description: Unidentified Debris

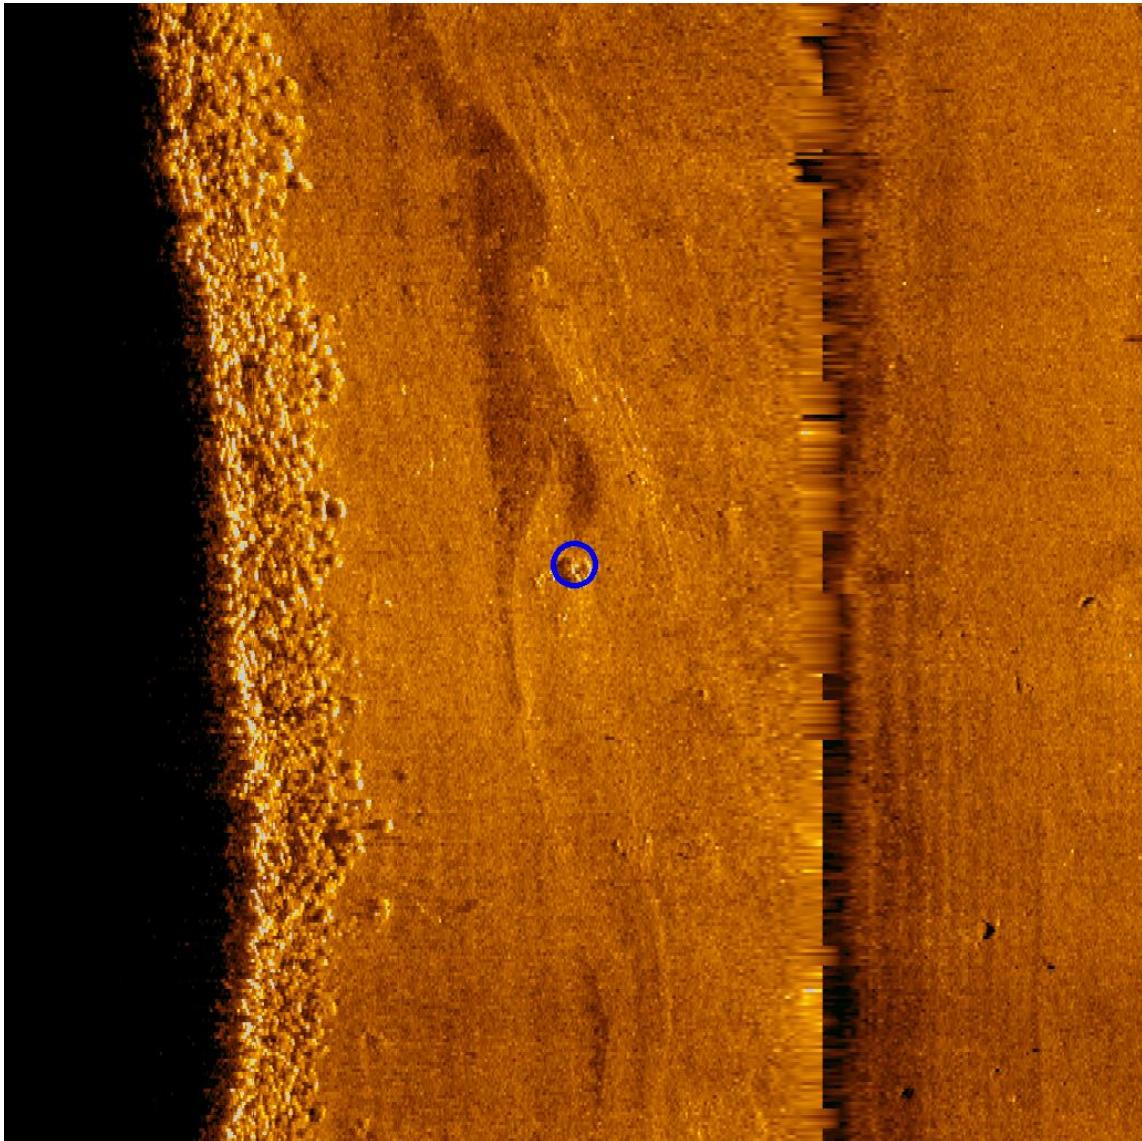
#### Contact 42

- Target Width: 2.71 US ft
- Target Length: 2.78 US ft
- Description: Possible Tire

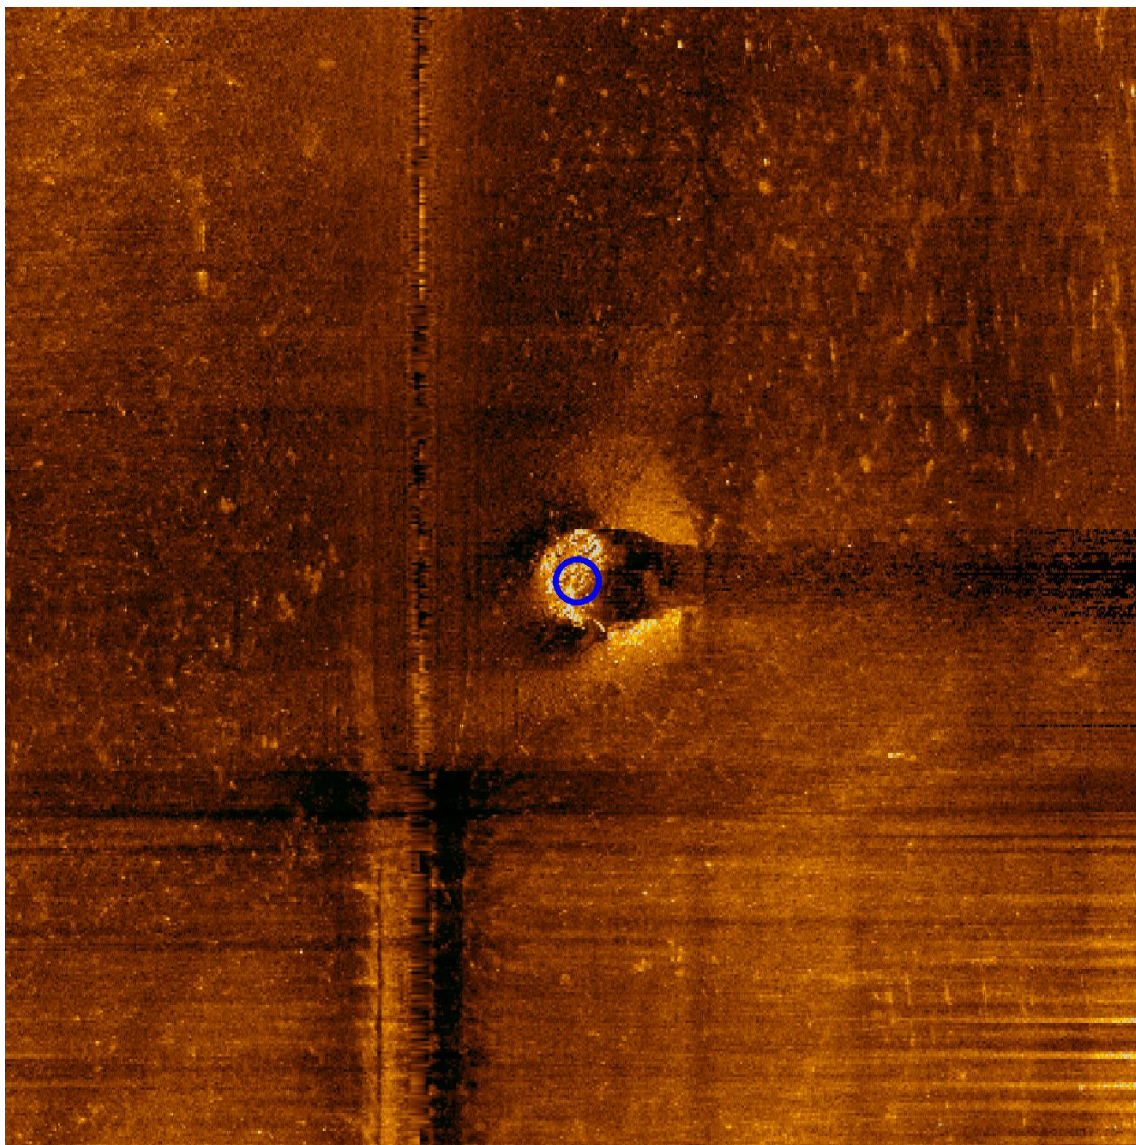
**Contact 43**

- Target Width: 11.31 US ft
- Target Length: 12.25 US ft
- Description: Unidentified Debris

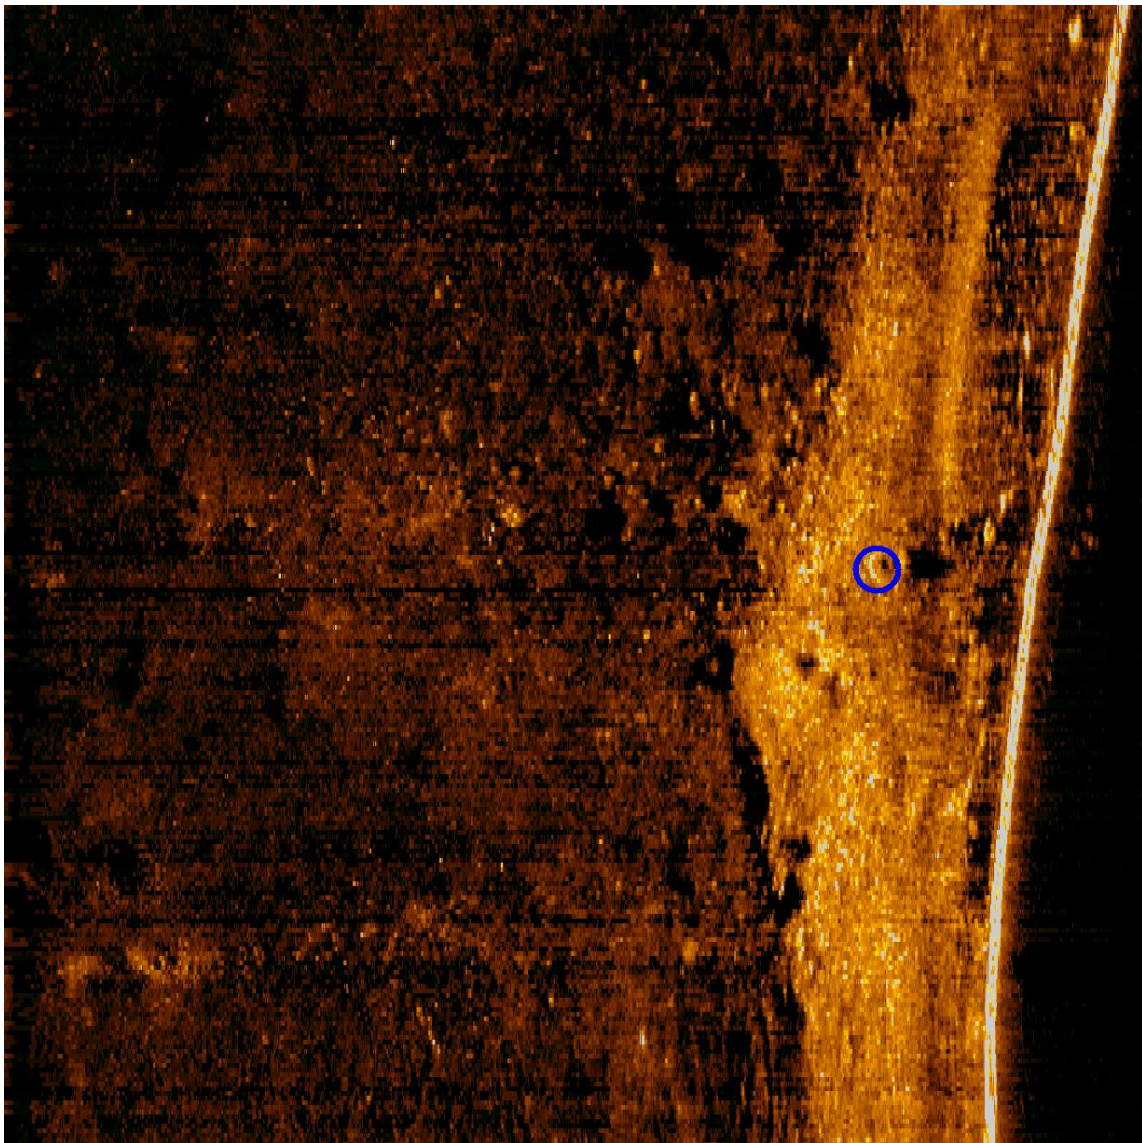
#### Contact 44

- Target Width: 4.43 US ft
- Target Length: 5.17 US ft
- Description: Unidentified Debris

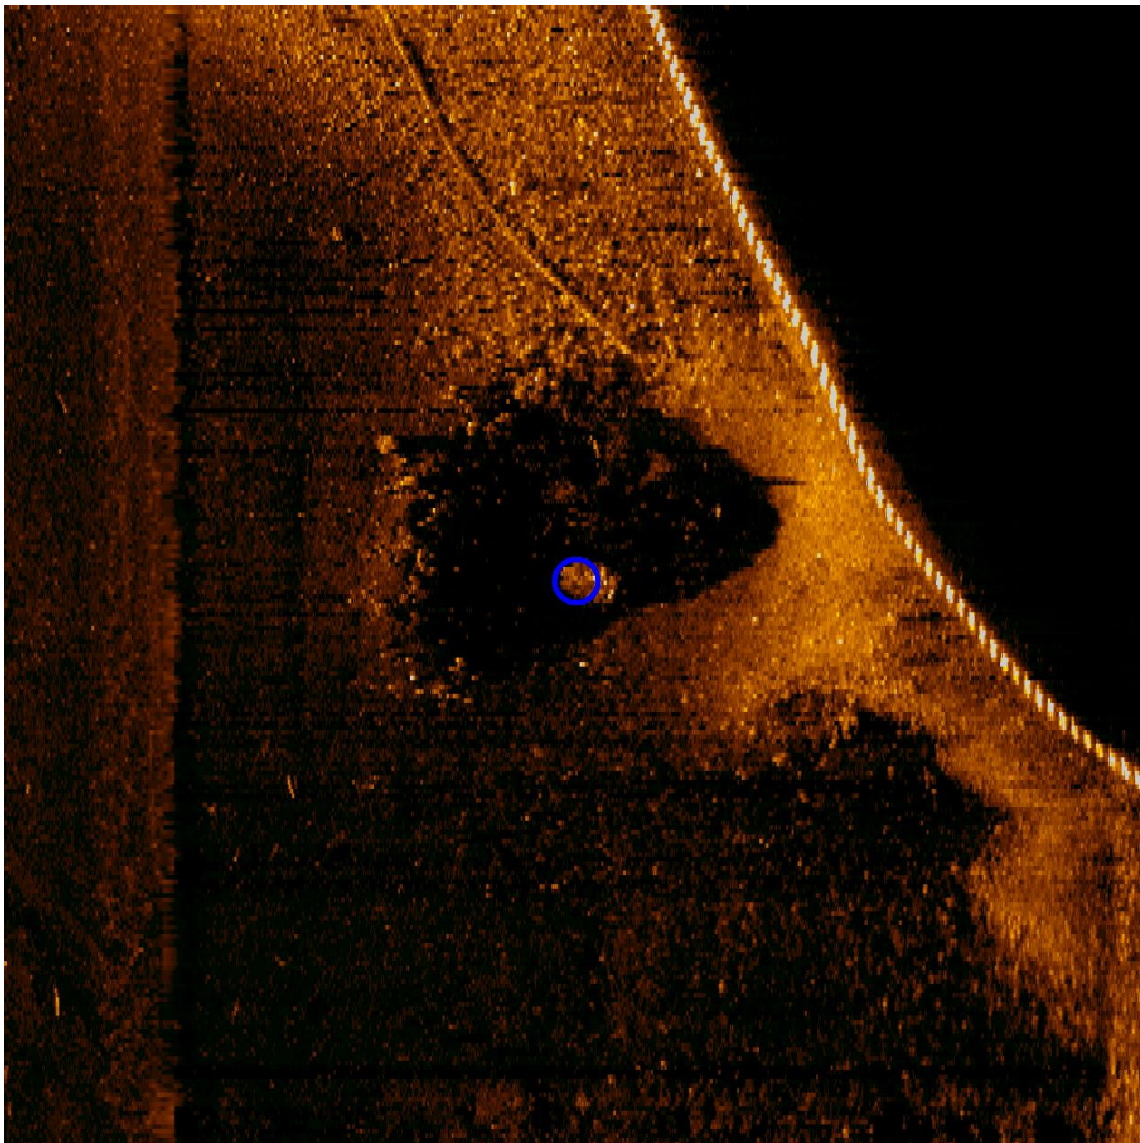
#### Contact 45

- Target Width: 45.66 US ft
- Target Length: 46.67 US ft
- Description: Unidentified Debris

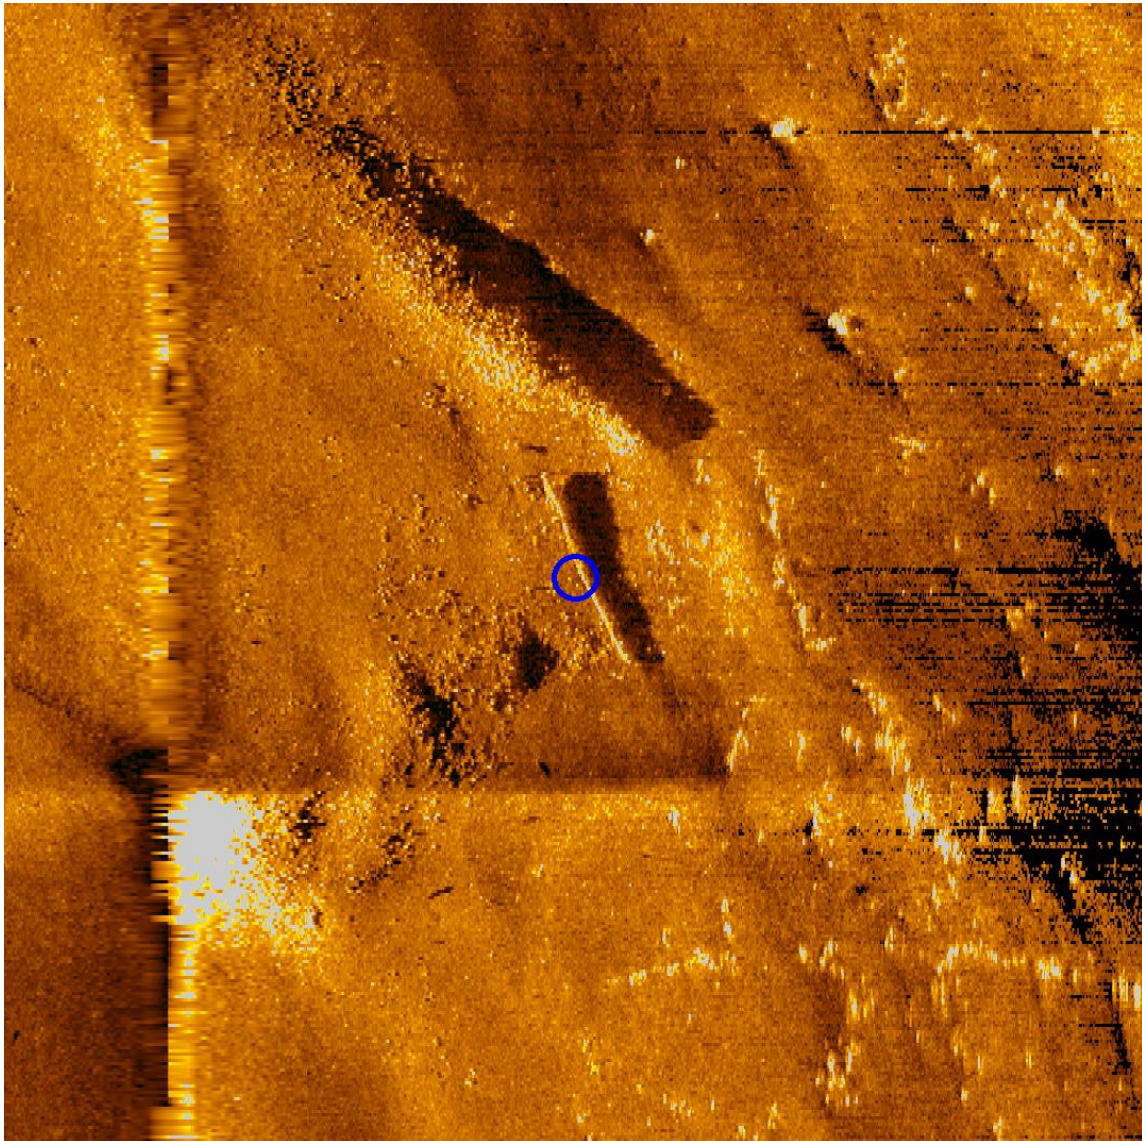
#### Contact 46

- Target Width: 2.12 US ft
- Target Length: 29.68 US ft
- Description: Unidentified Debris

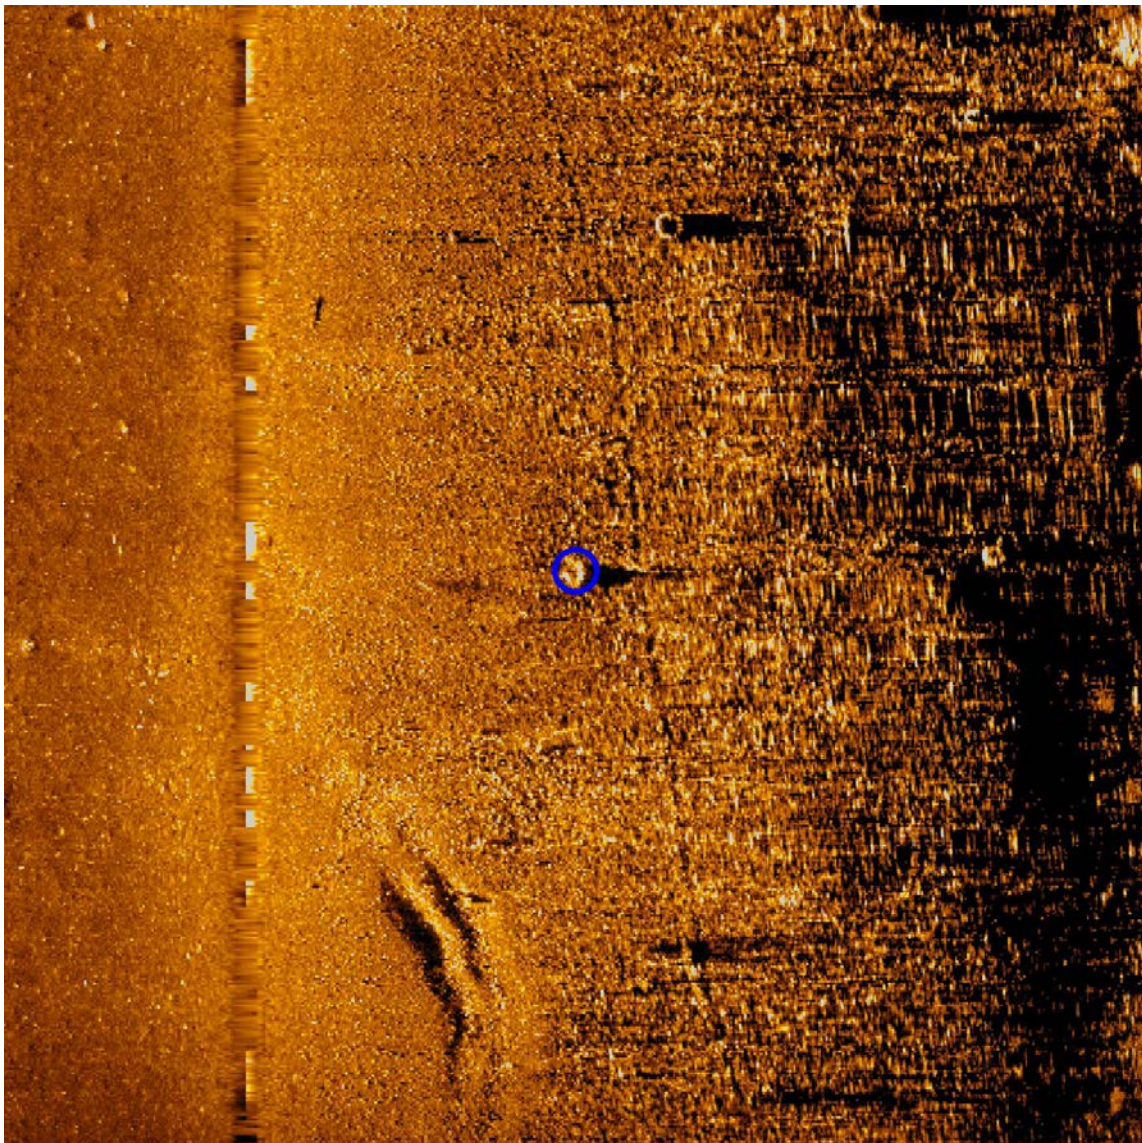
#### Contact 47

- Target Width: 3.01 US ft
- Target Length: 2.88 US ft
- Description: Possible Tire

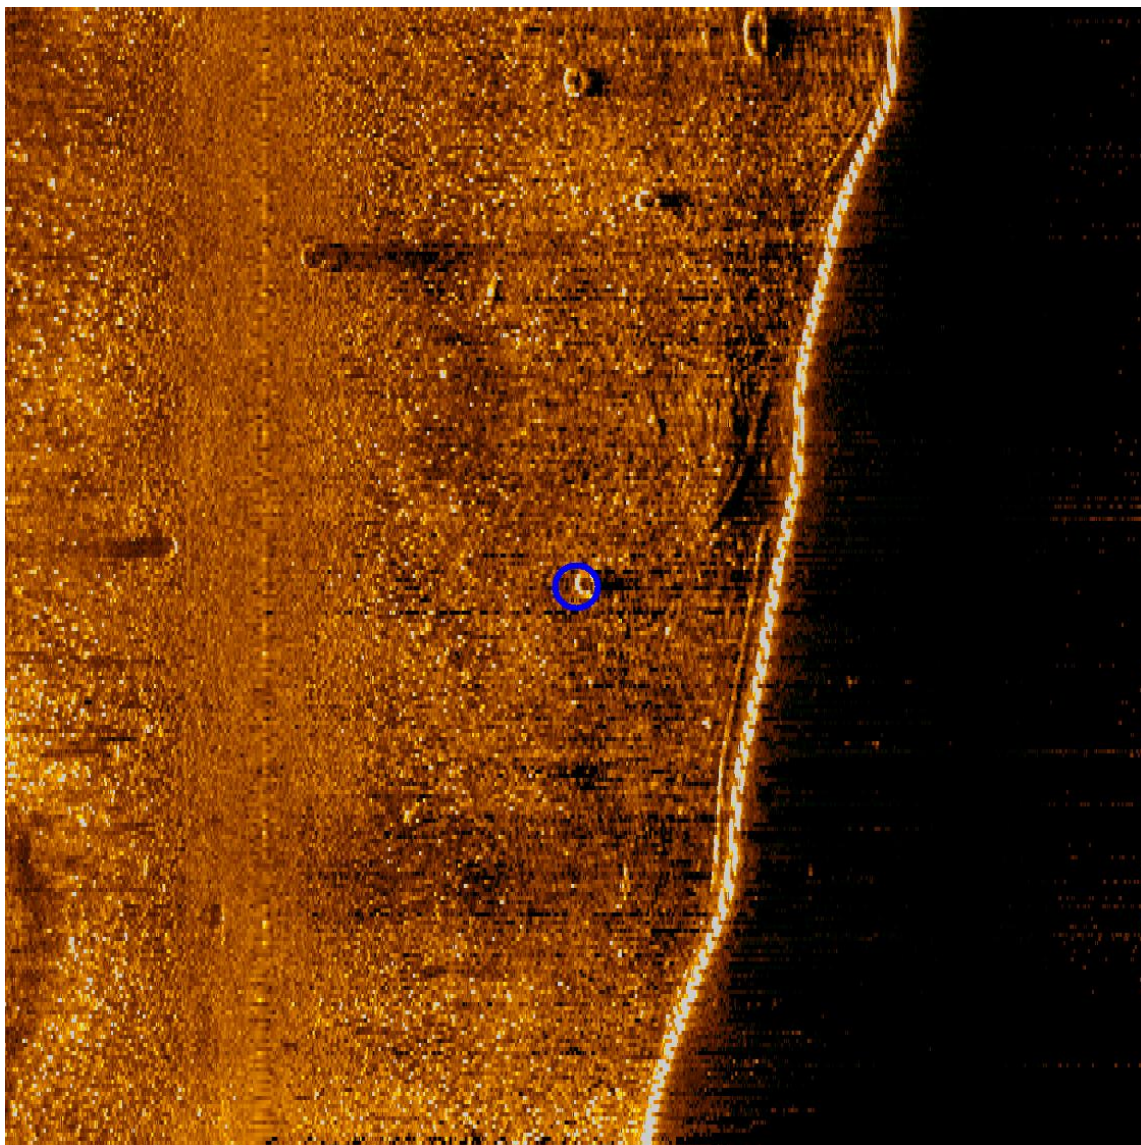
#### Contact 48

- Target Width: 2.50 US ft
- Target Length: 3.30 US ft
- Description: Possible Tire

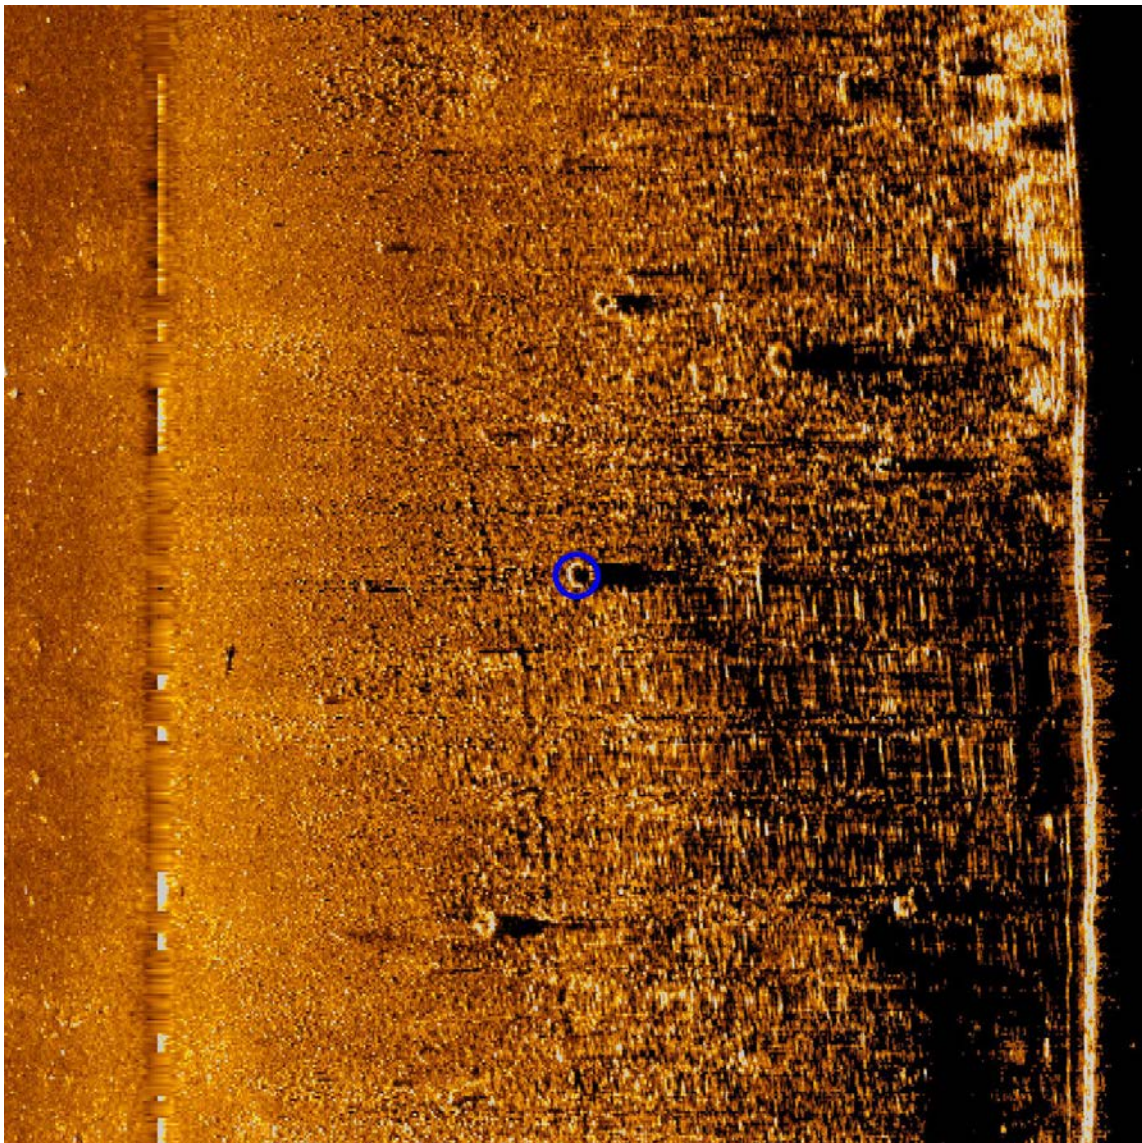
#### Contact 49

- Target Width: 2.31 US ft
- Target Length: 2.42 US ft
- Description: Possible Tire

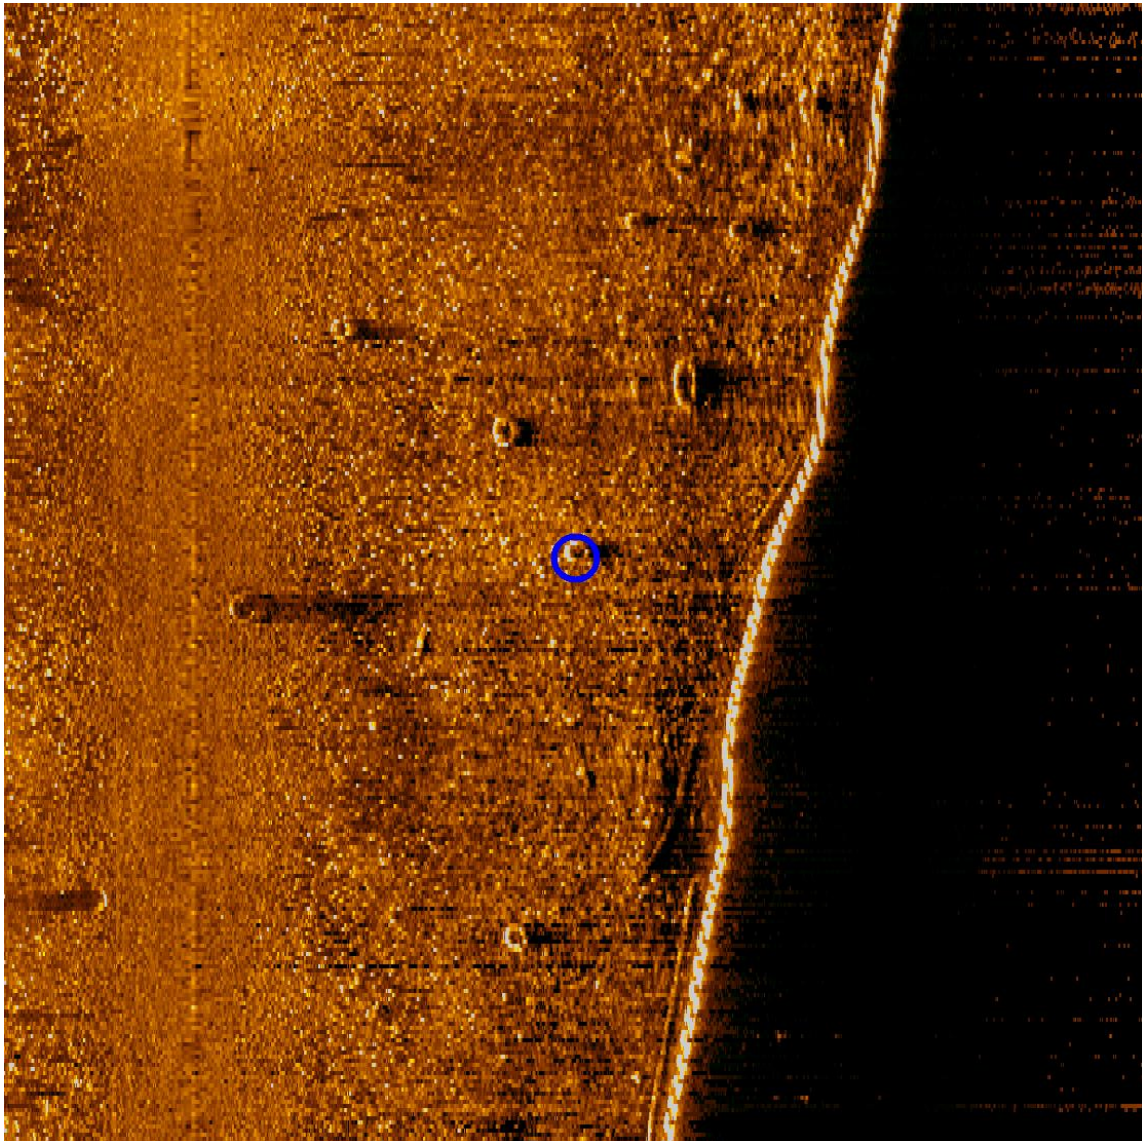
#### Contact 50

- Target Width: 2.43 US ft
- Target Length: 2.73 US ft
- Description: Possible Tire

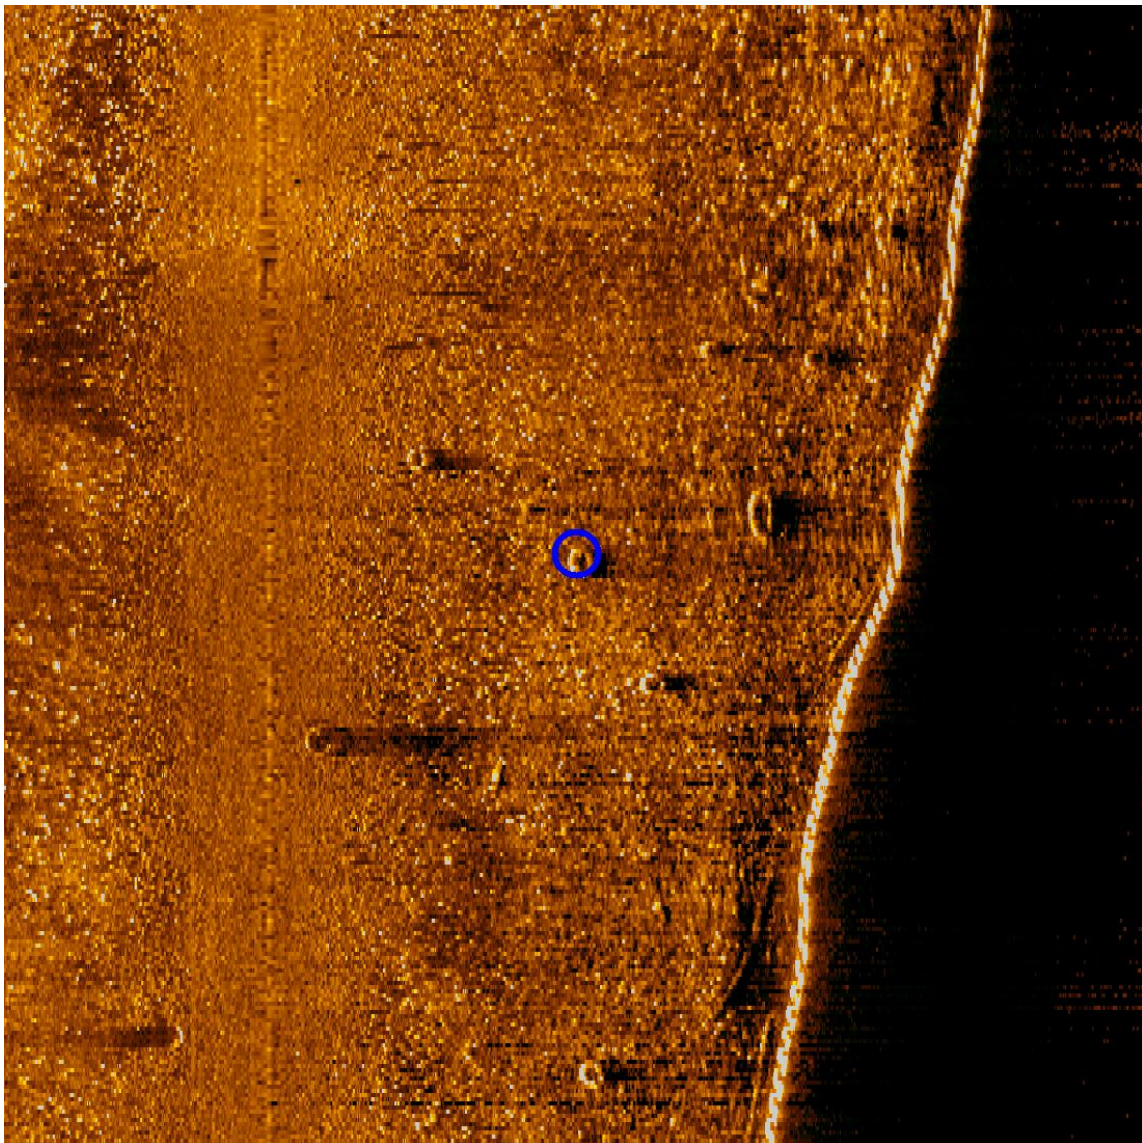
#### Contact 51

- Target Width: 2.81 US ft
- Target Length: 3.74 US ft
- Description: Possible Tire
