# **Hazard Survey for Port Houston – Expansion Channel Improvement Project – Amendment 6 Spilmans Island/Morgan’s Point Geophysical Survey**

Methodology Report | Harris County, Texas

1910781042 02 | September 15, 2020

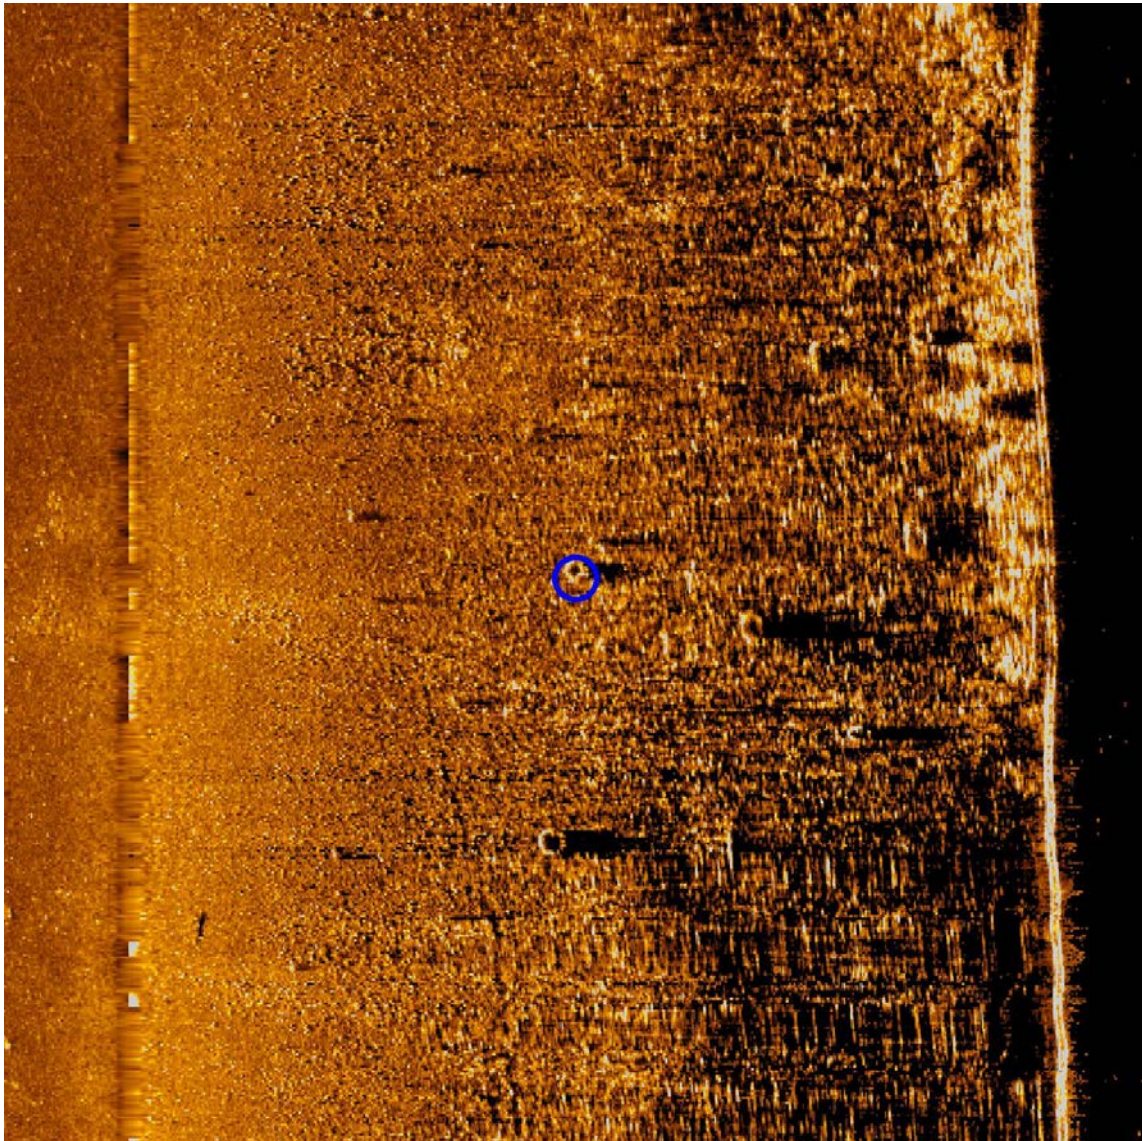
#### Contact 52

- Target Width: 2.68 US ft
- Target Length: 2.69 US ft
- Description: Possible Tire

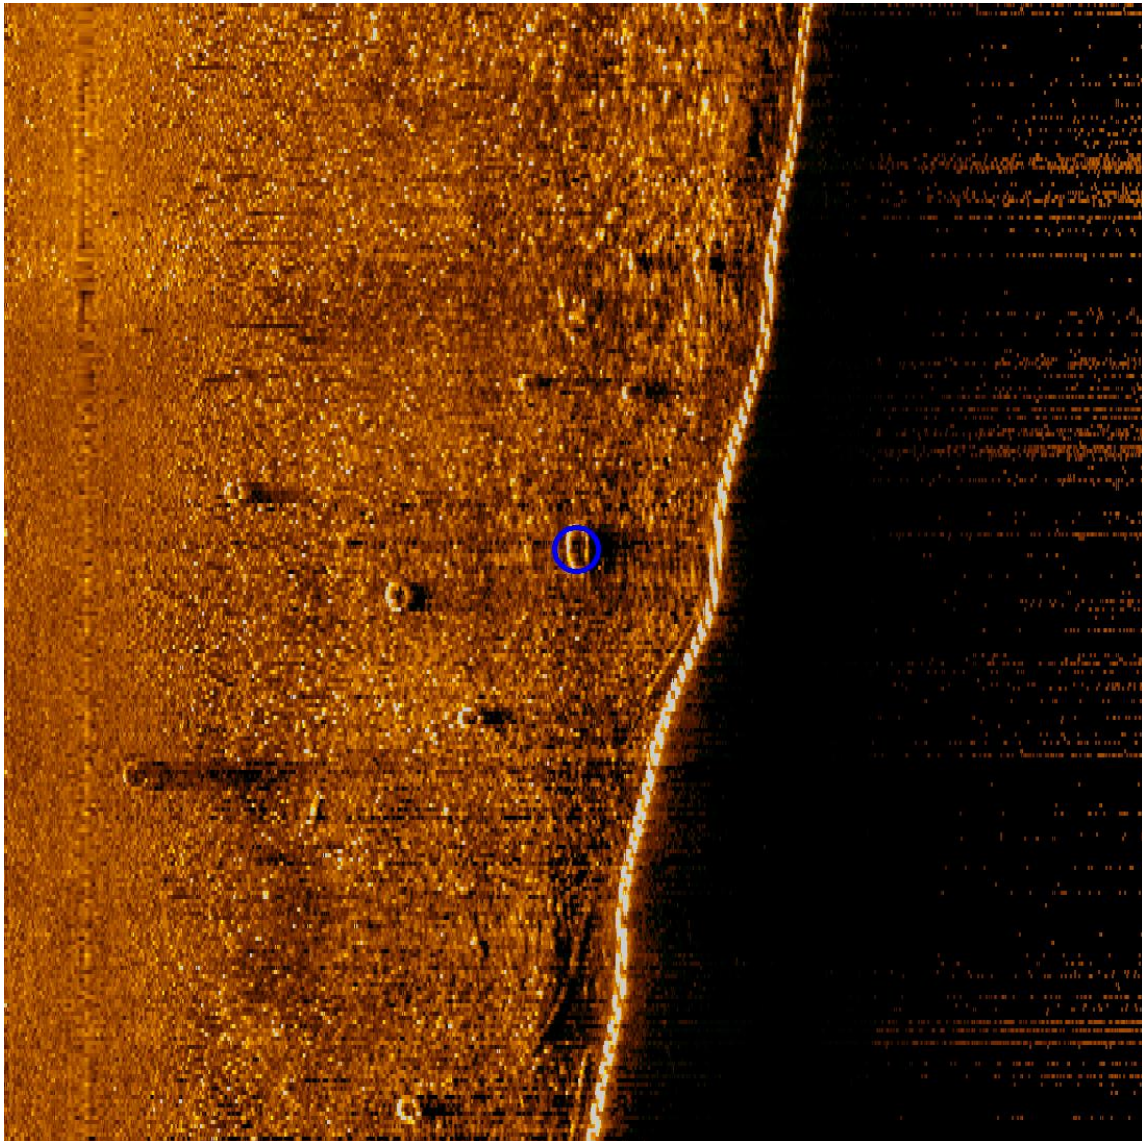
**Contact 53**

- Target Width: 2.82 US ft
- Target Length: 6.32 US ft
- Description: Possible Tire

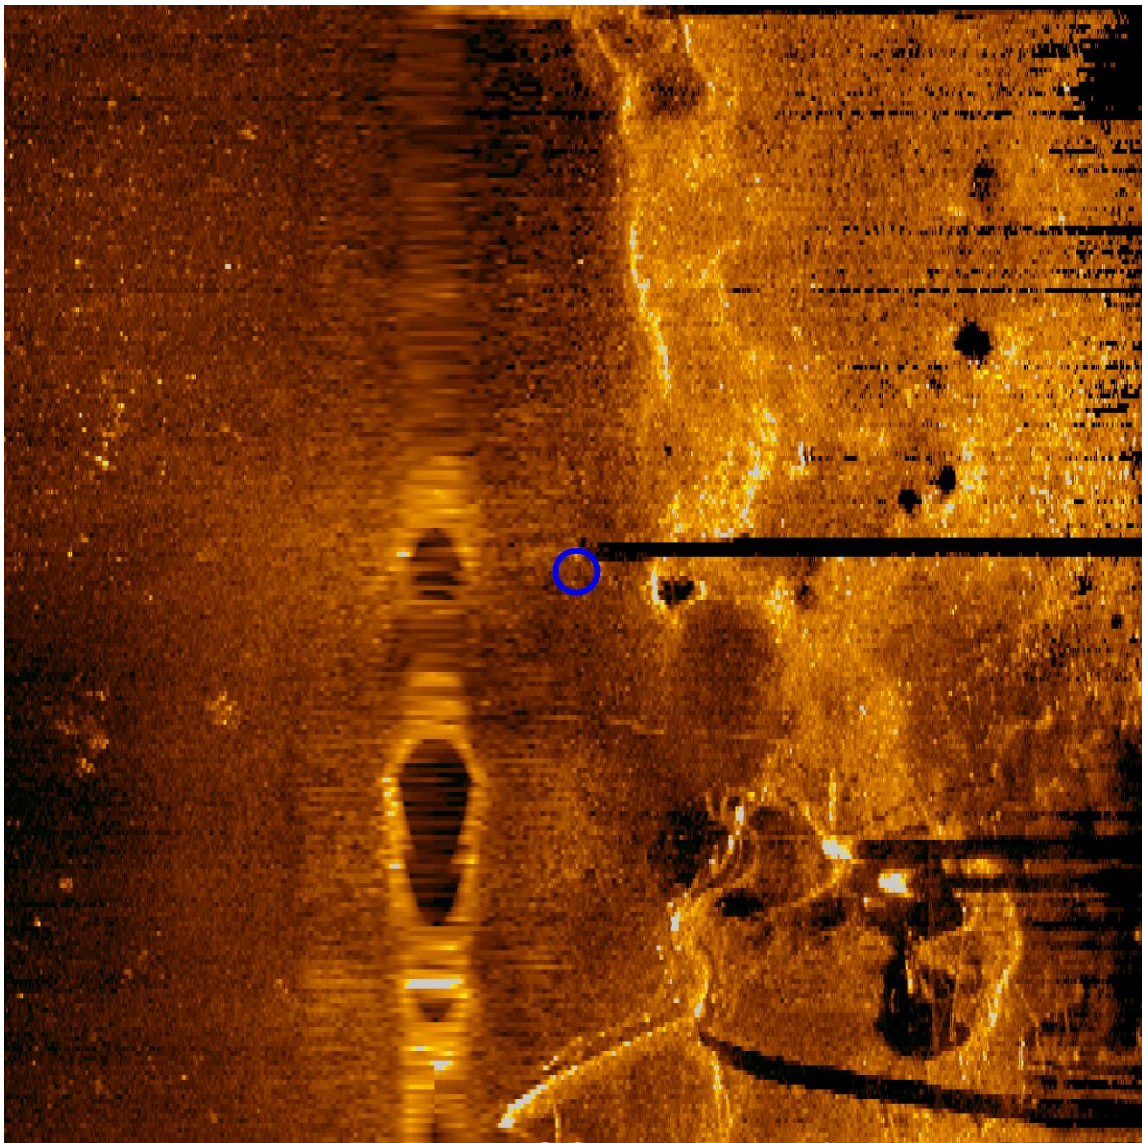
#### Contact 54

- Target Width: 2.96 US ft
- Target Length: 2.87 US ft
- Description: Possible Piling, possibly ferrous due to alignment with magnetometer anomaly.

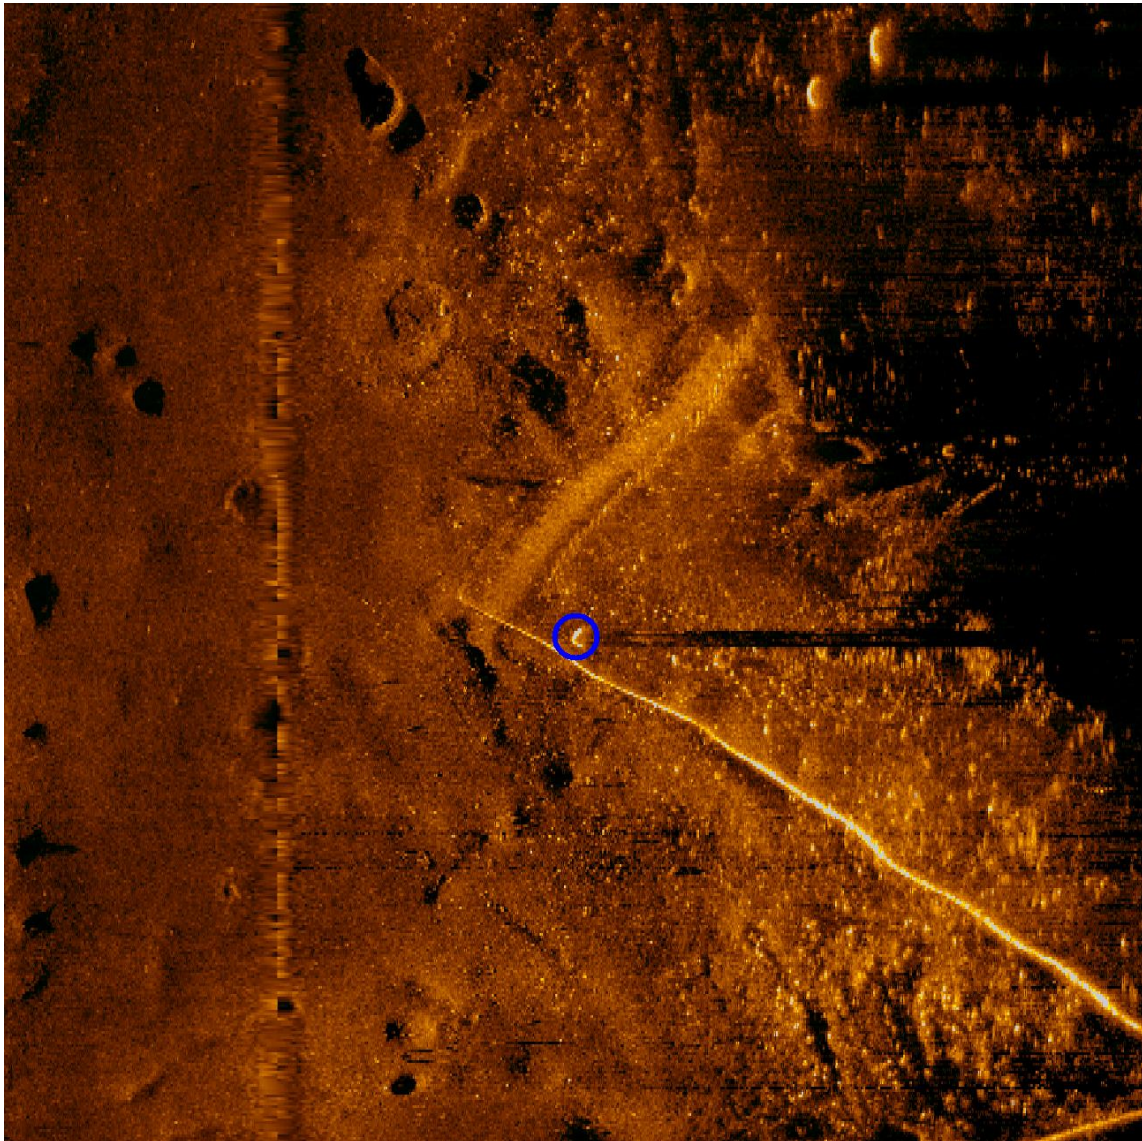
#### Contact 55

- Target Width: 1.66 US ft
- Target Length: 2.57 US ft
- Description: Possible Piling

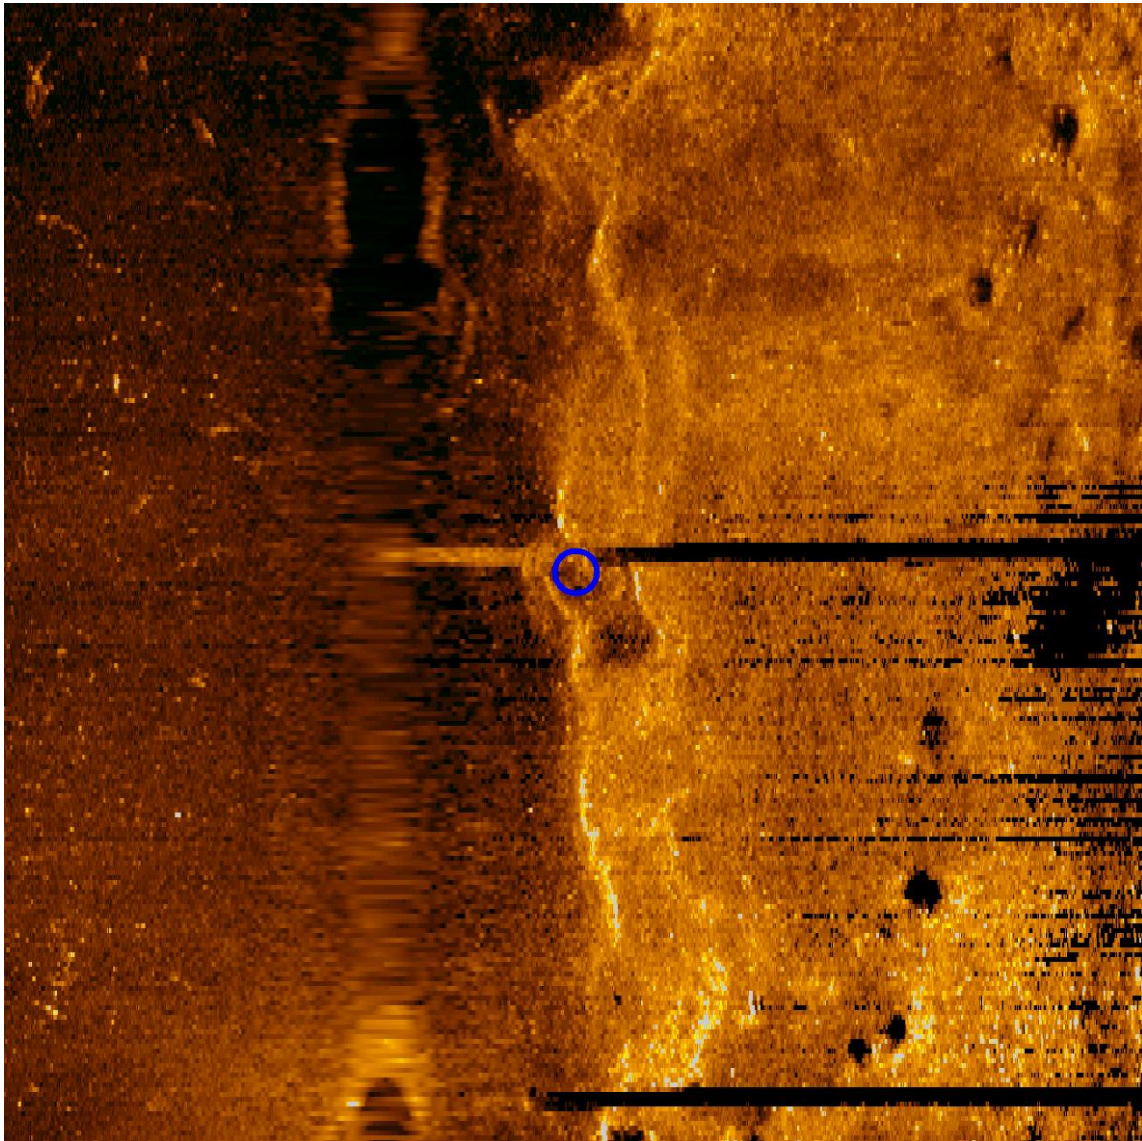
#### Contact 56

- Target Width: 1.80 US ft
- Target Length: 2.35 US ft
- Description: Possible Piling, possibly ferrous due to alignment with magnetometer anomaly.

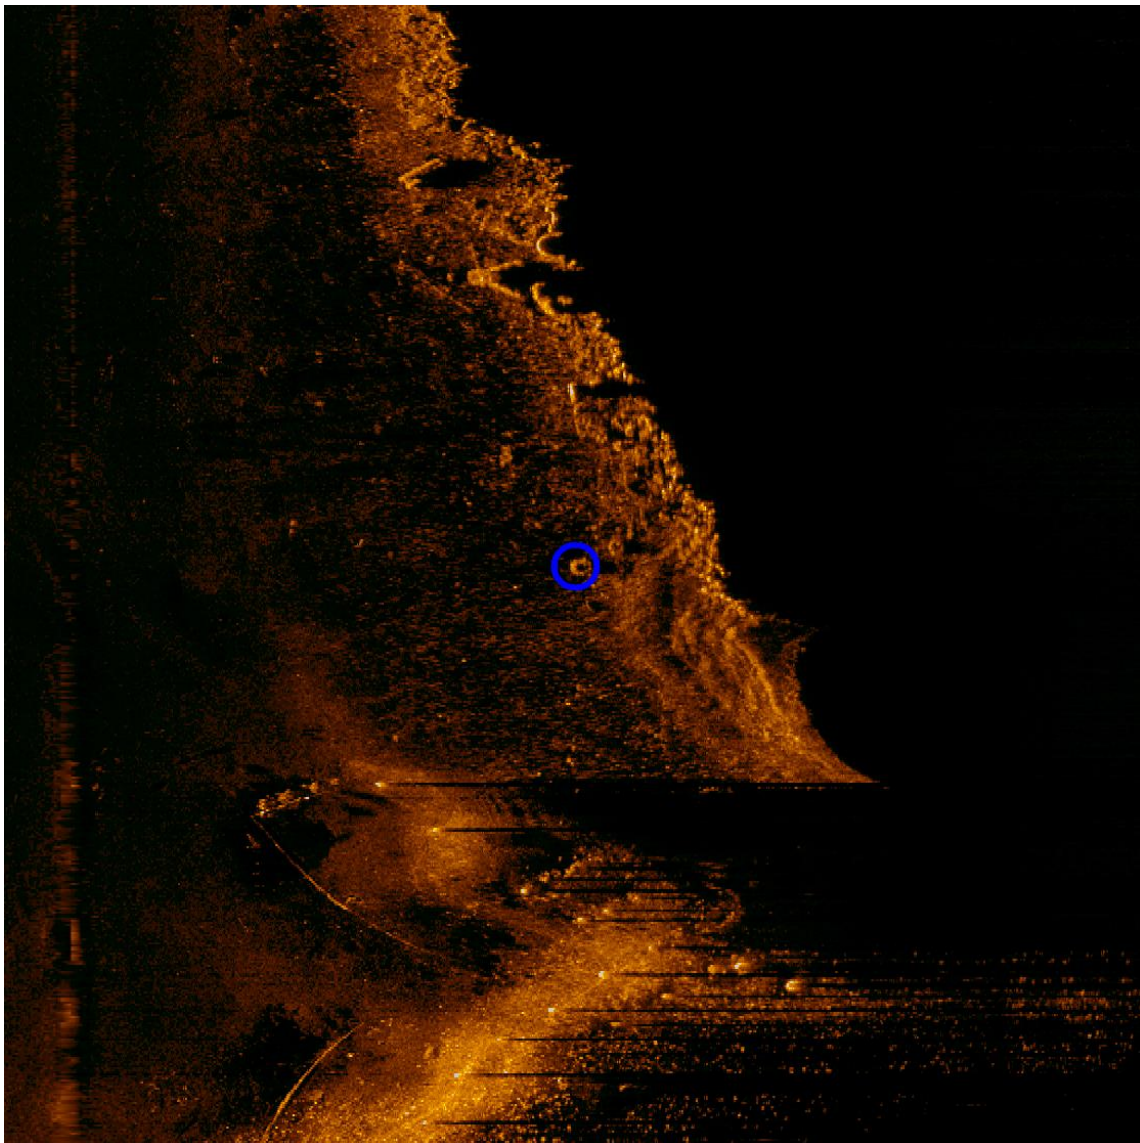
#### Contact 57

- Target Width: 2.82 US ft
- Target Length: 2.08 US ft
- Description: Possible Tire

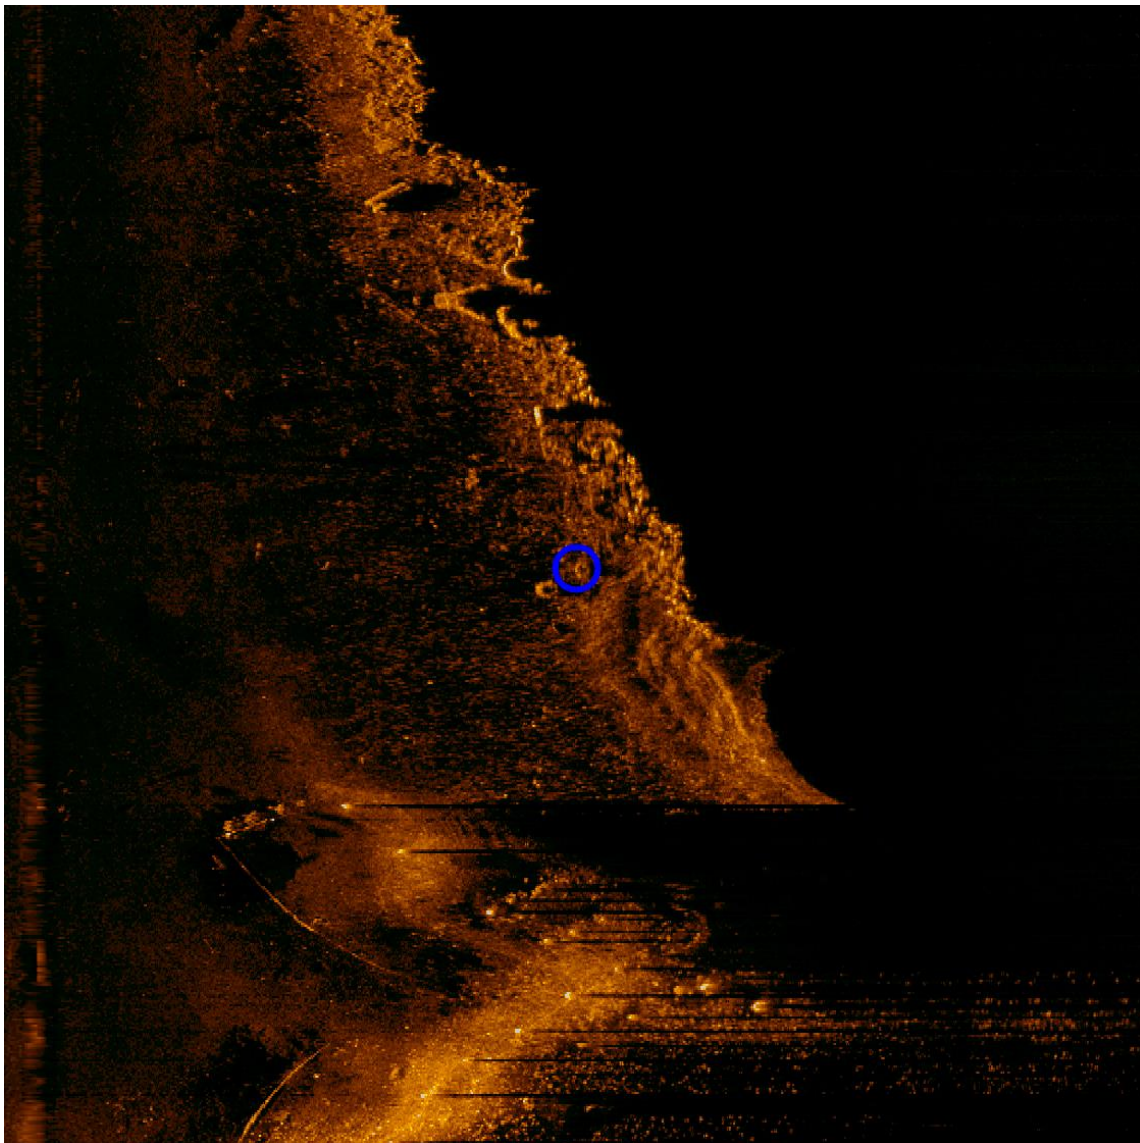
#### Contact 58

- Target Width: 1.74 US ft
- Target Length: 2.61 US ft
- Description: Possible Tire

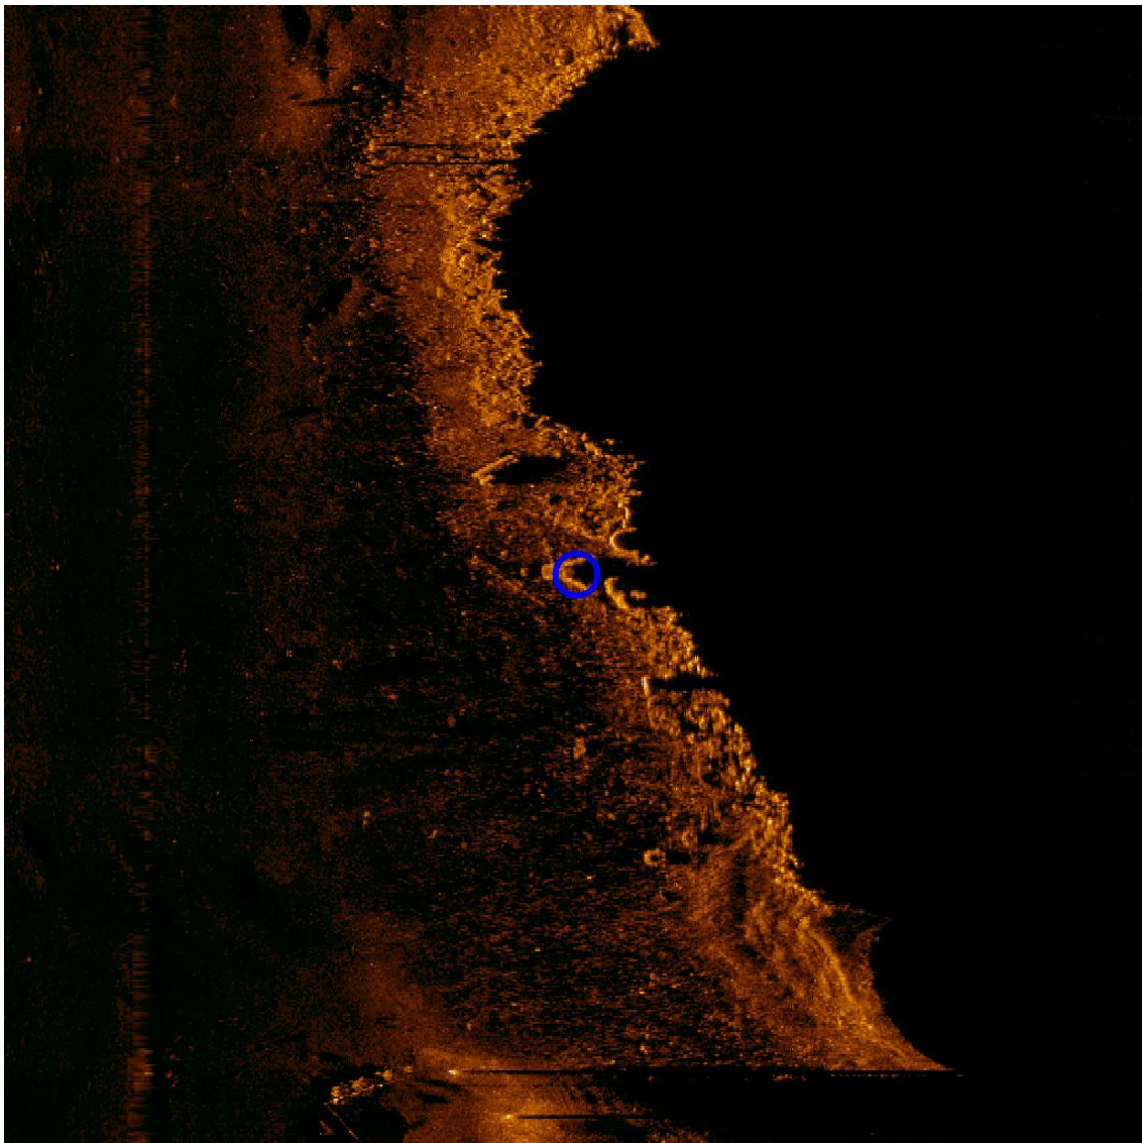
**Contact 59**

- Target Width: 7.53 US ft
- Target Length: 8.14 US ft
- Description: Unidentified Debris

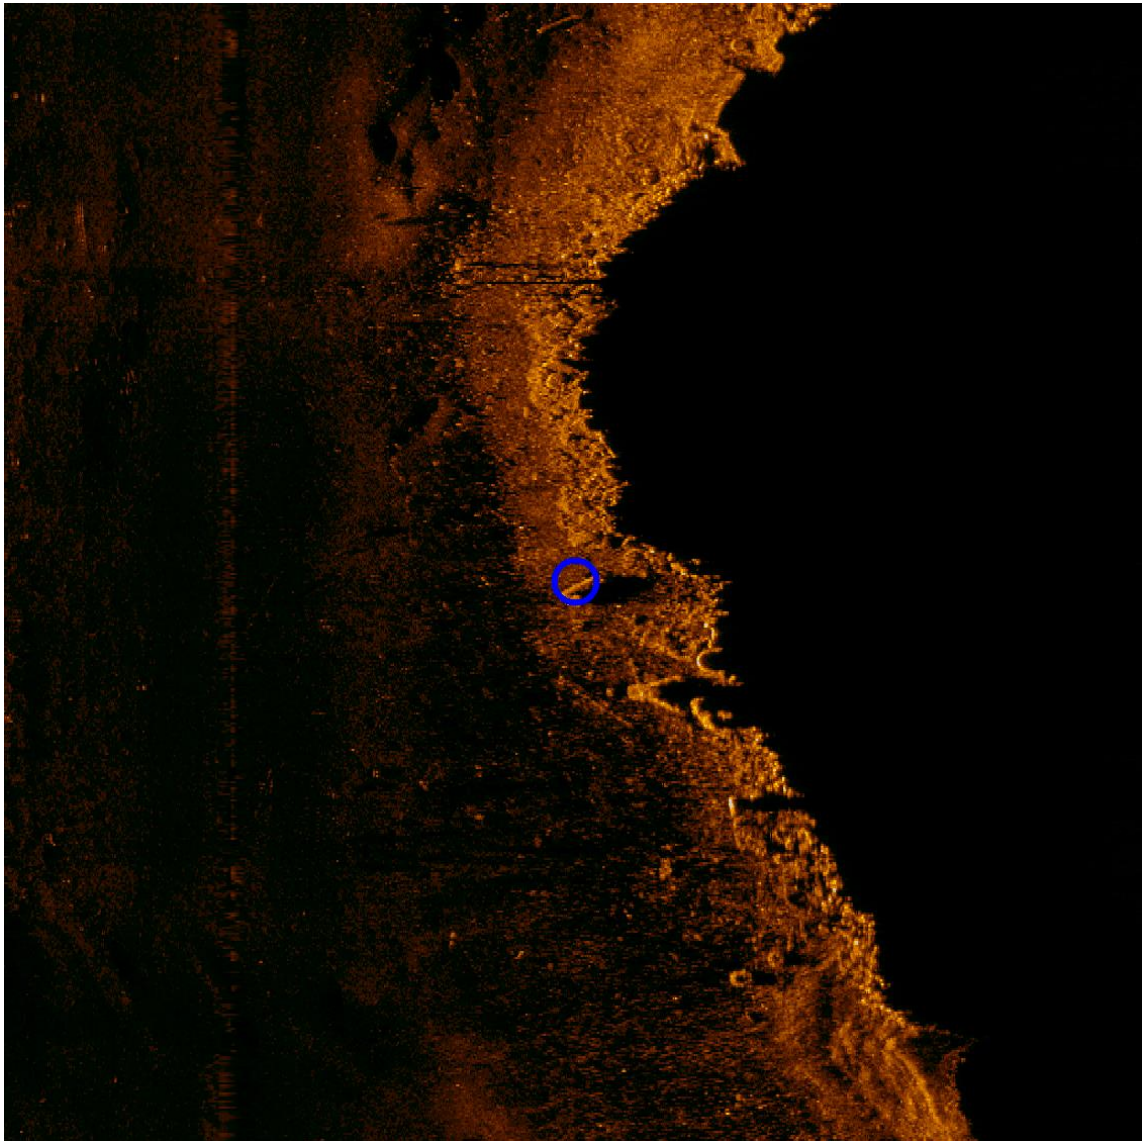
**Contact 60**

- Target Width: 2.97 US ft
- Target Length: 7.05 US ft
- Description: Unidentified Debris

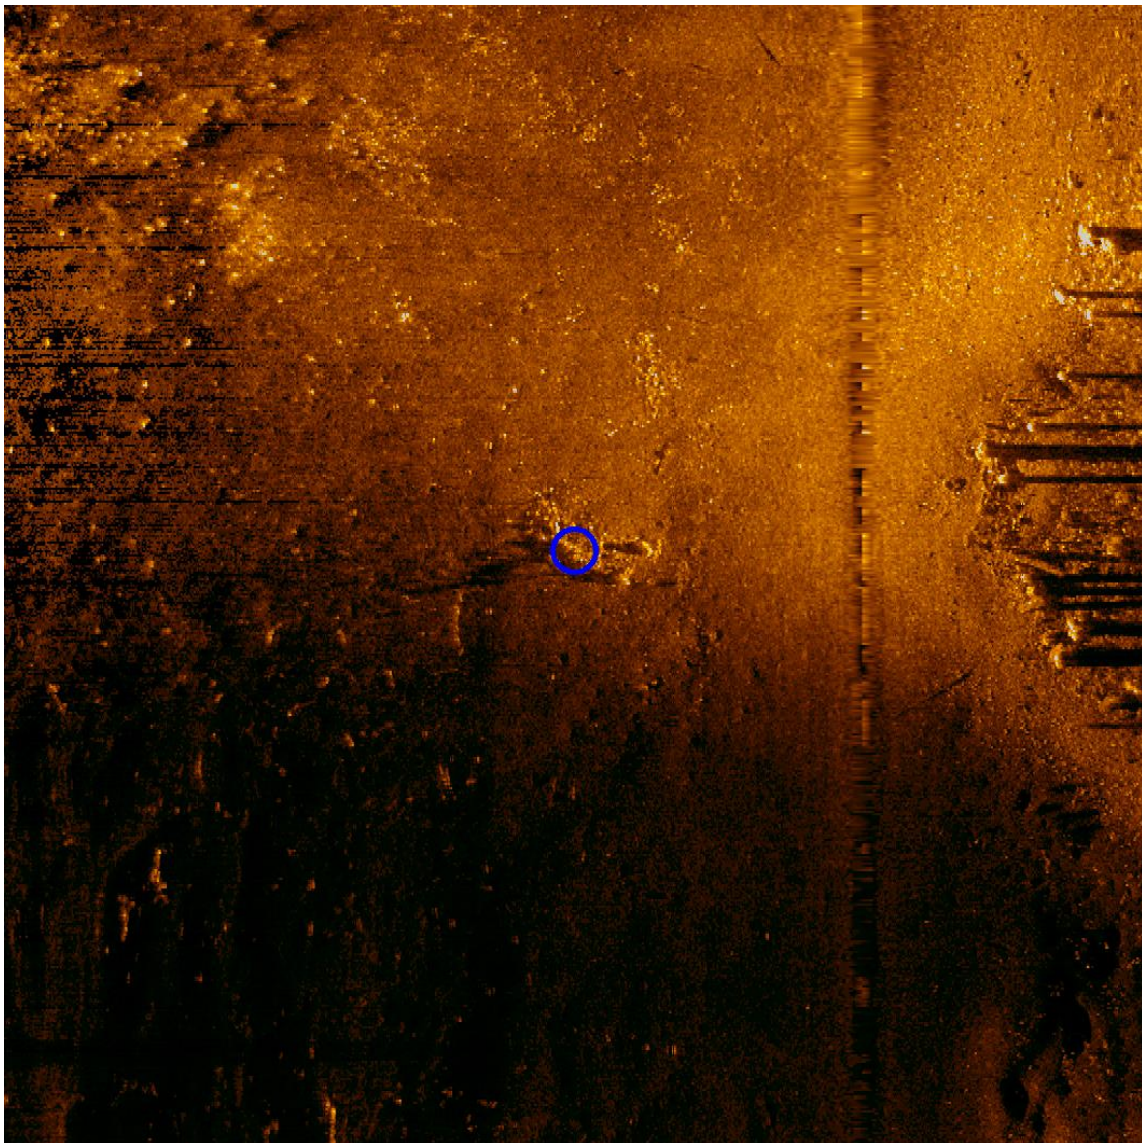
#### Contact 61

- Target Width: 8.71 US ft
- Target Length: 16.78 US ft
- Description: Unidentified Debris

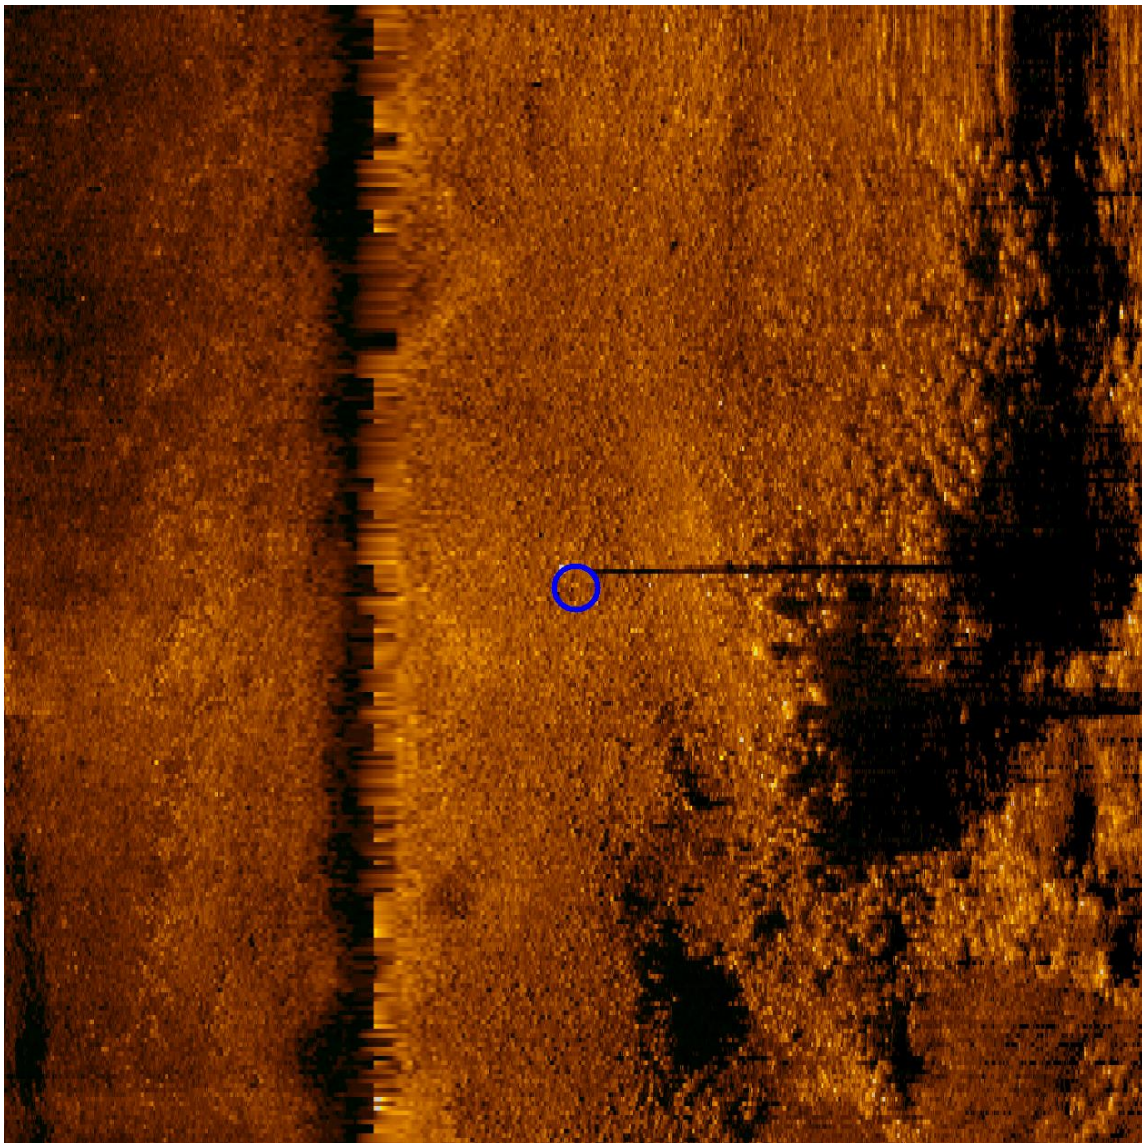
#### Contact 62

- Target Width: 1.69 US ft
- Target Length: 0.97 US ft
- Description: Possible Piling, possibly ferrous due to alignment with magnetometer anomaly.

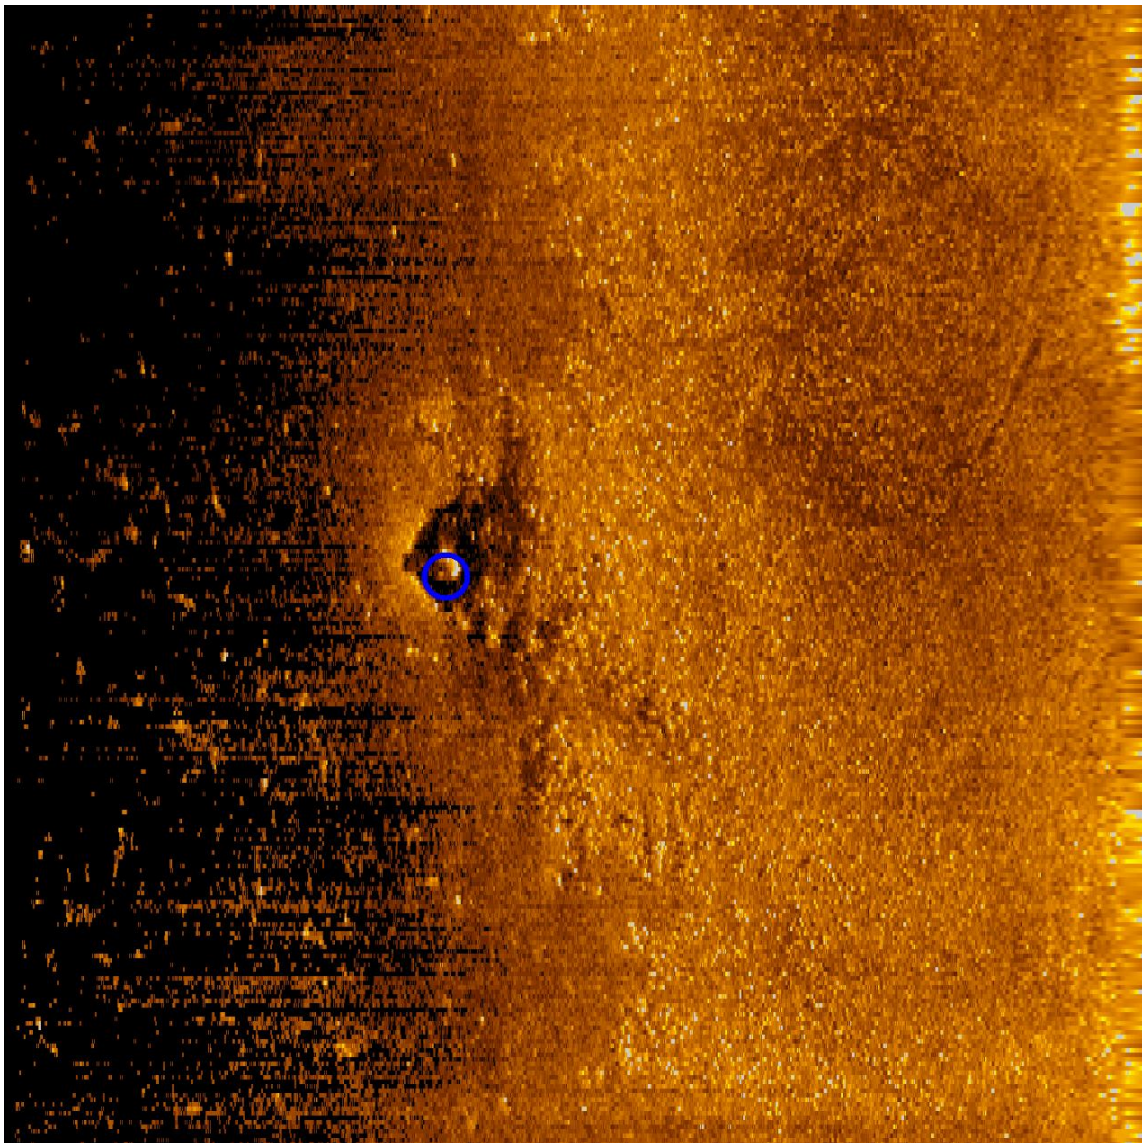
#### Contact 63

- Target Width: 11.04 US ft
- Target Length: 14.05 US ft
- Description: Unidentified Debris
