# **Hazard Survey for Port Houston – Expansion Channel Improvement Project – Amendment 6 Spilmans Island/Morgan’s Point Geophysical Survey**

Methodology Report | Harris County, Texas

1910781042 02 | September 15, 2020

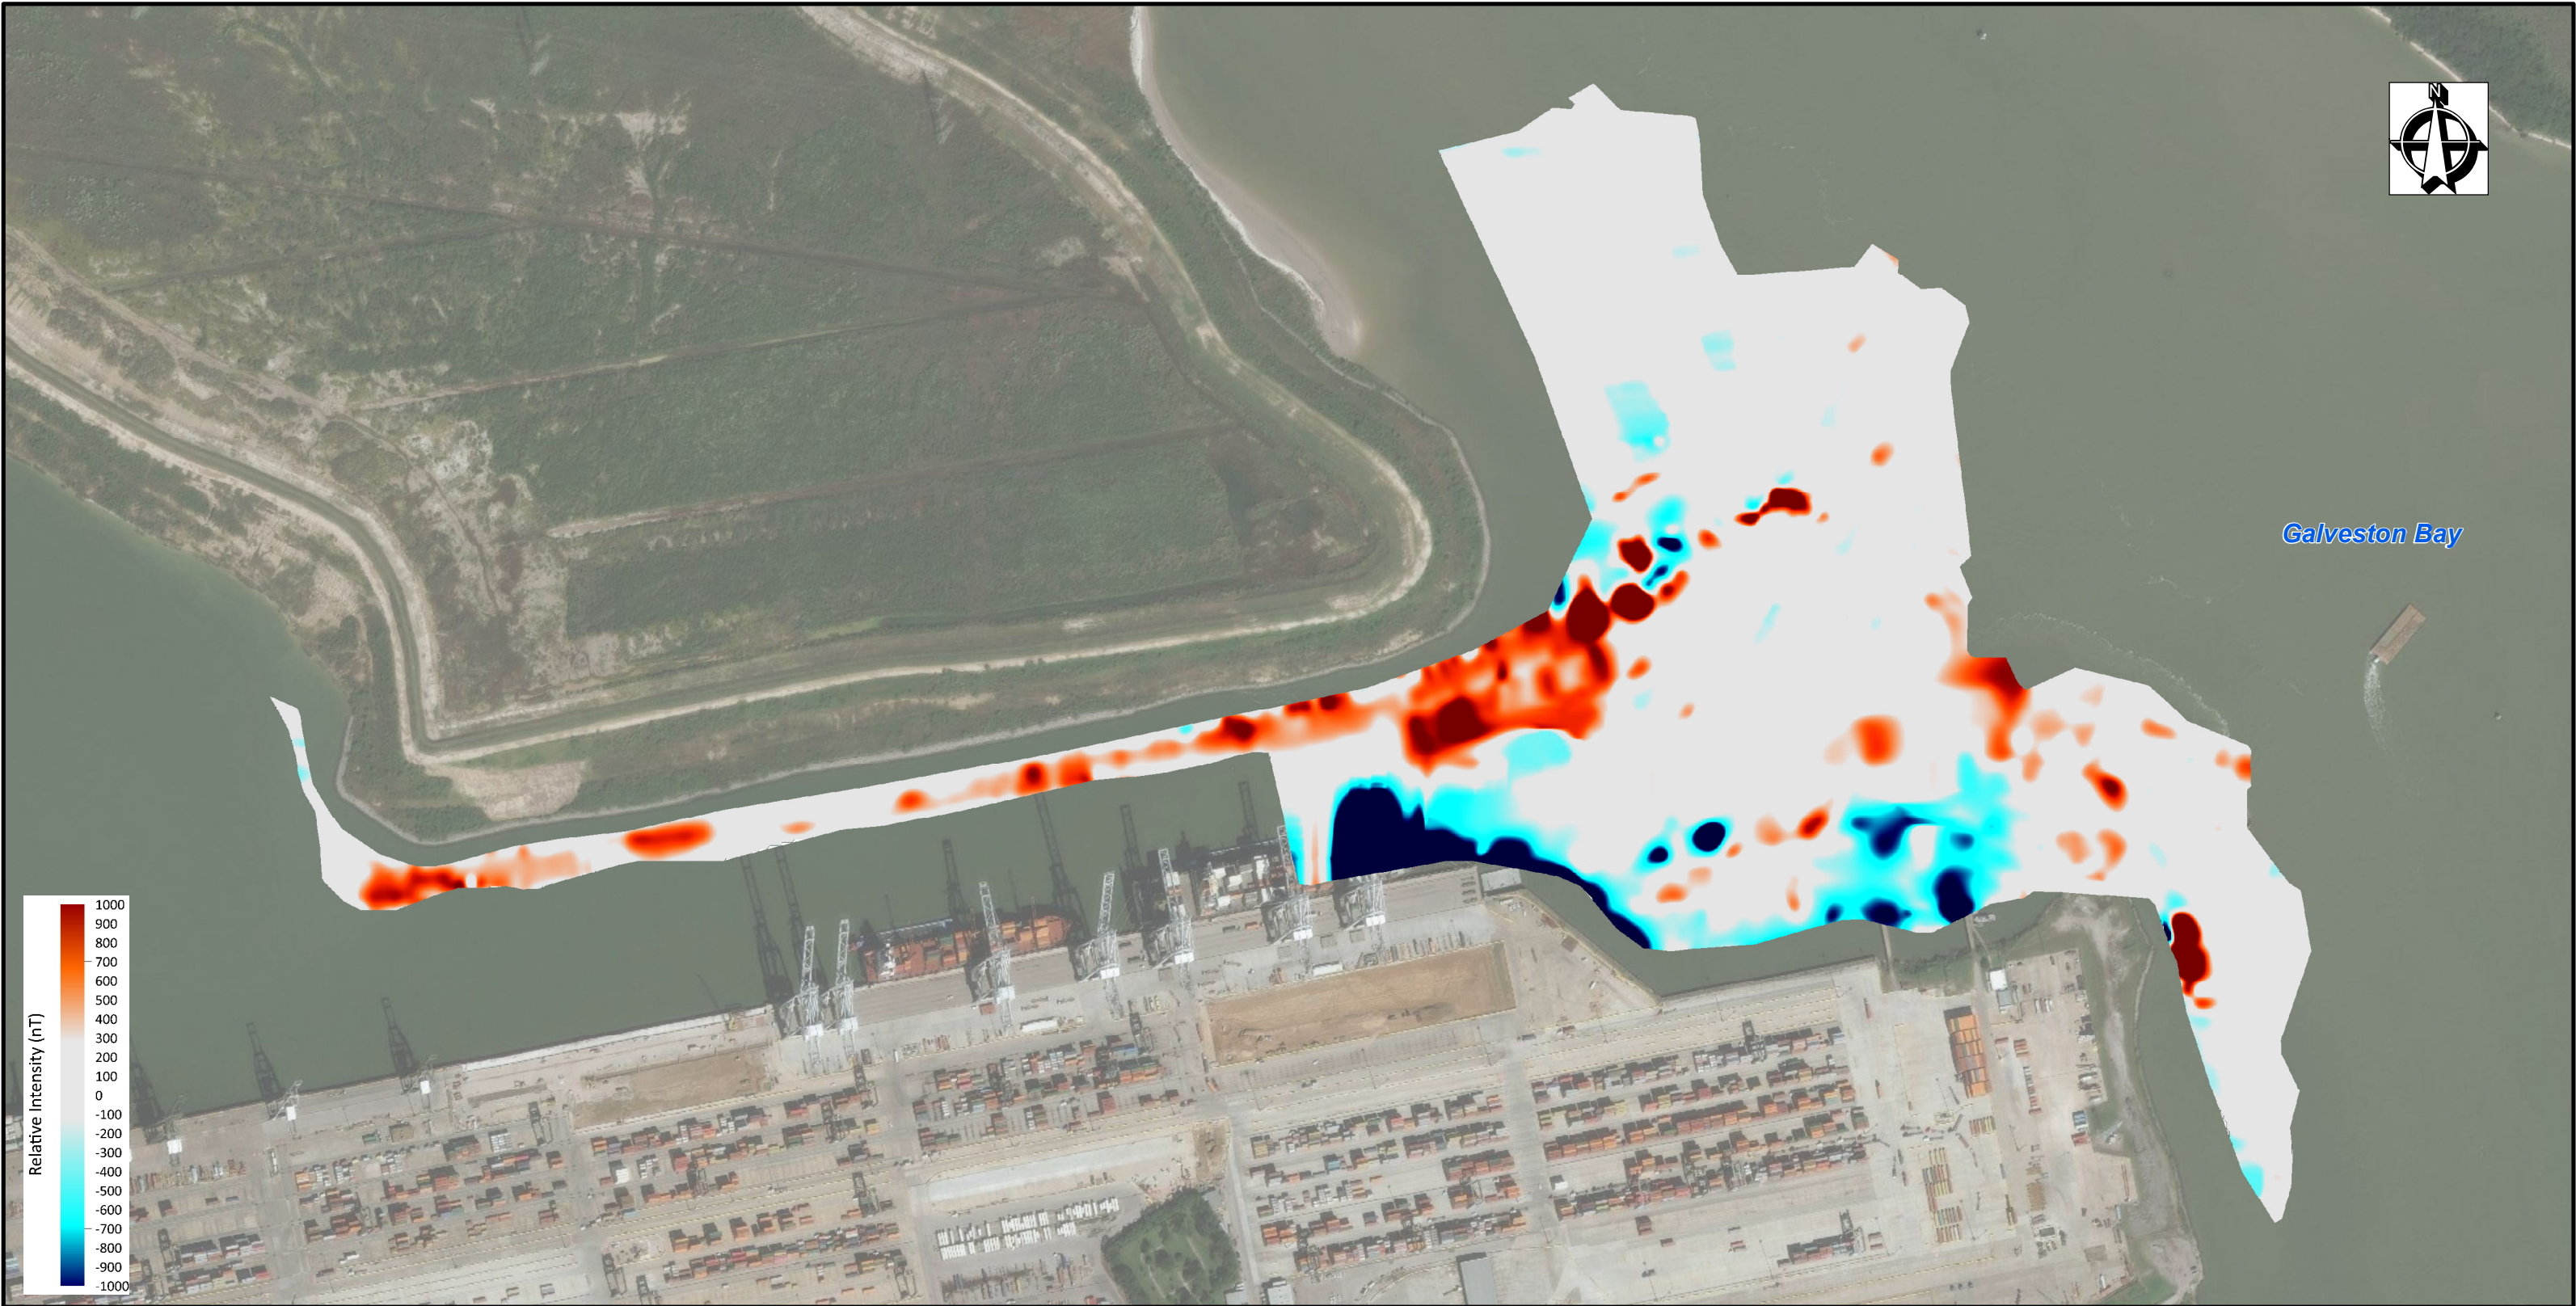
While interpreting the magnetometer data, there is a distinct anomaly on the southeastern portion of Spilmans Island. These anomalies do not correlate to any hazards seen in the sidescan sonar data; however, when plotted in plan-view with mapped locations of pre-existing structures, the anomalies appear to geospatially align with old infrastructure that is visible in historical aerial imagery. However, these magnetometer anomalies are the only evidence that aligns with old infrastructure. In many areas where structures are documented in historical imagery, new and unique structures are shown to have replaced them throughout the time elapsing between their initial construction and the present. The remaining magnetometer anomalies seem to align with existing infrastructures such as docks, bulkheads, piling clusters, etc.
